# 4-Point Inspection Form

Insured/Applicant Name: Ellen and Ray Castellano Application / Policy #: CIT-4417-PH-2026  
Address Inspected: 4417 Palm Hollow Drive, Port Charlotte, FL 33948  
Actual Year Built: 1998 Date Inspected: 09/25/2026

# Photograph Addendum

Florida 4-Point Inspection - Citizens Insp4pt 03 25 - 4417 Palm Hollow Drive, Port Charlotte, FL 33948 - 09/25/2026

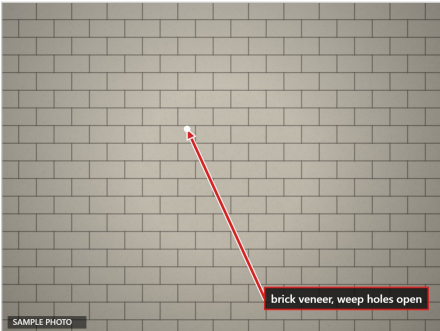
Front elevation - brick veneer, weep holes open (1 of 4)

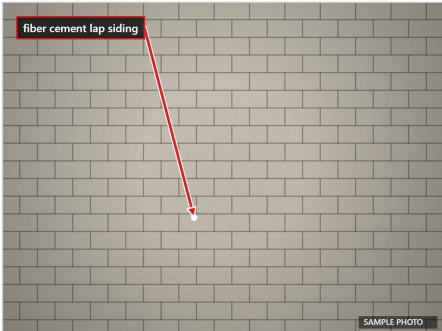
Right elevation - fiber cement lap siding (2 of 4)

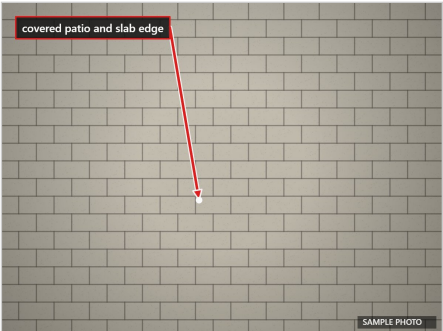
Rear elevation - covered patio and slab edge (3 of 4)

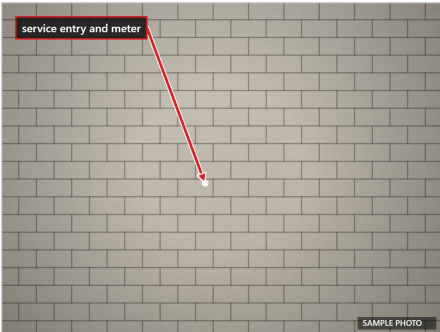
Left elevation - service entry and meter (4 of 4)

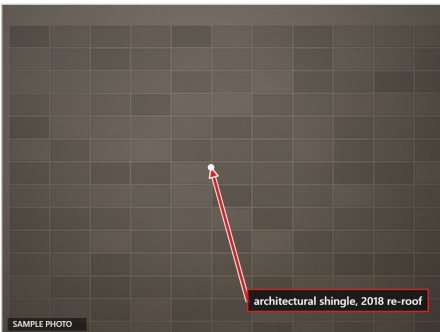
South slope - architectural shingle, 2018 re-roof (1 of 4)

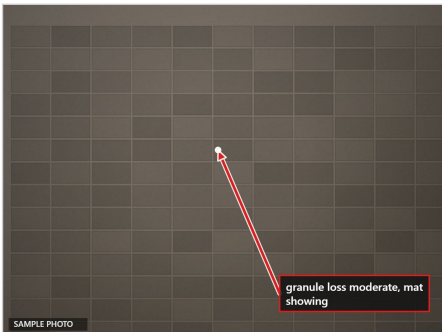
West slope - granule loss moderate, mat showing (2 of 4)

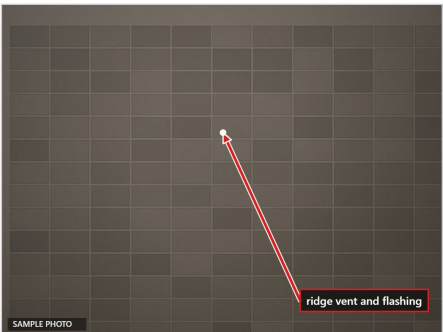
North slope - ridge vent and flashing (3 of 4)

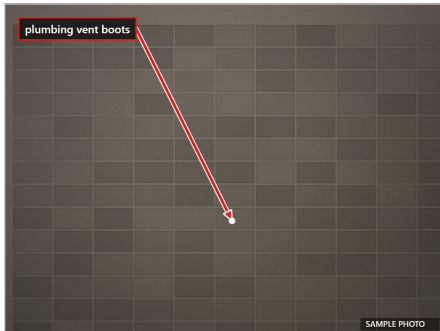
East slope - plumbing vent boots (4 of 4)

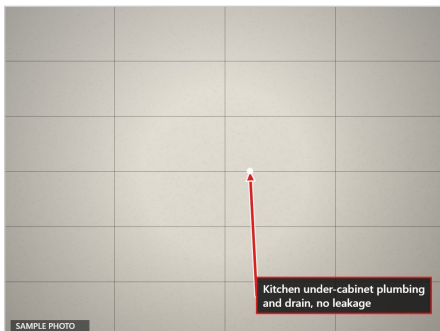
Kitchen under-cabinet plumbing and drain, no leakage

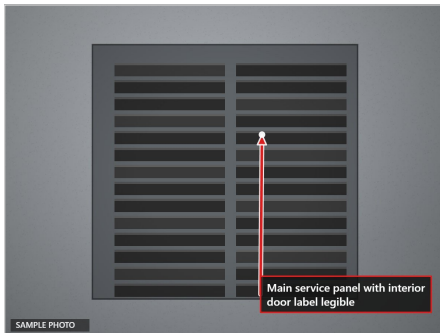
Main service panel with interior door label legible

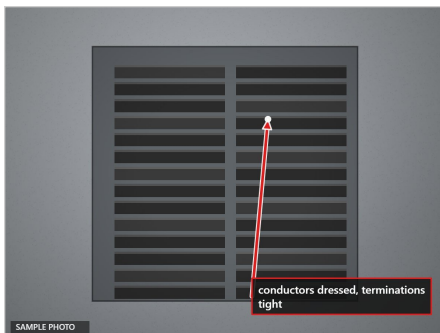
Dead front removed - conductors dressed, terminations tight

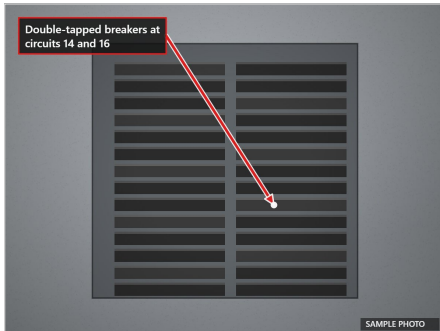
Two double-tapped breakers observed at circuits 14 and 16 - two branch conductors under a single lug rated for one. No bonding jumper at the water meter, leaving the metallic water piping unbonded across the meter.

Double-tapped breakers at circuits 14 and 16 (1 of 3)

Both are correctable by a licensed electrician at modest cost. No scorching, no overheating and no evidence of arcing at any termination examined.

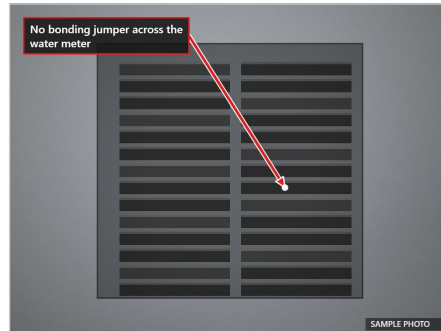
No bonding jumper across the water meter (2 of 3)

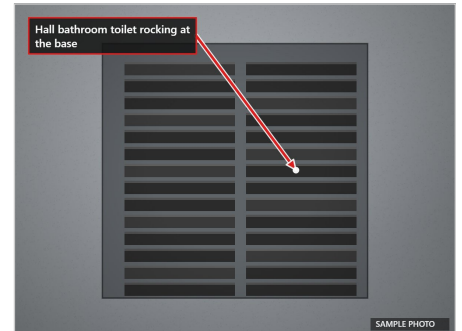
Hall bathroom toilet rocks at the base and the wax seal shows prior seepage staining on the subfloor collar. No active leak at the time of inspection. Supply piping is copper throughout the accessible areas.

Hall bathroom toilet rocking at the base (3 of 3)
