**LIBERTY RIDGE**

# Home Inspection Report

**Property:** 214 Ridgeline Court, Cherry Hill, NJ 08003

**Type of Inspection:** Buyer's pre-purchase inspection

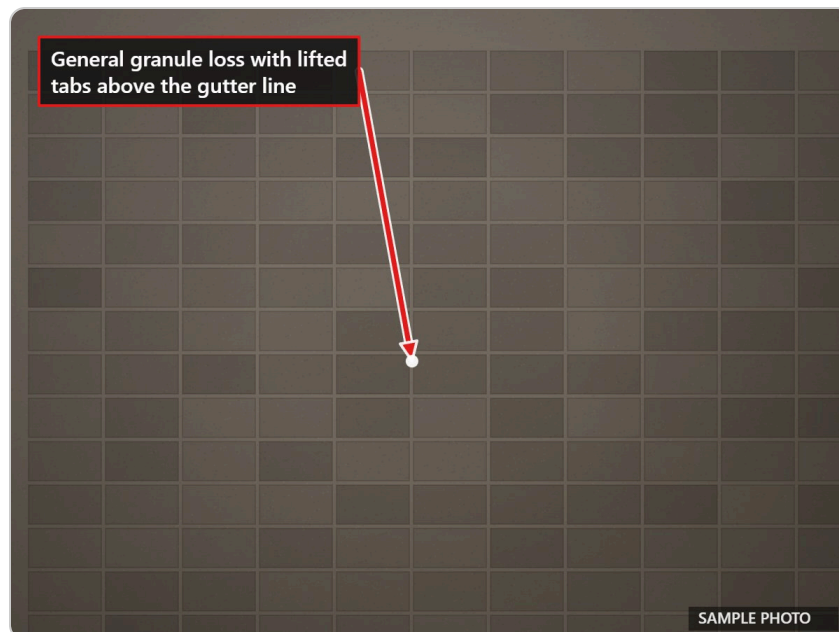
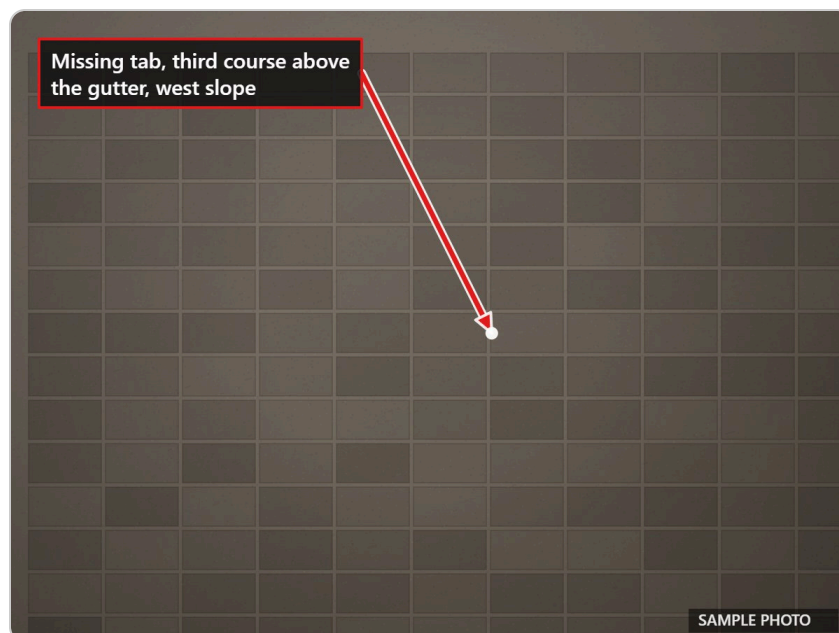
## Roof coverings

**Notes:** Three-tab asphalt shingles with granule loss that is moderate and general across the south and west slopes. Several tabs on the west slope are lifted and one is missing at the third course above the gutter. Based on the wear pattern and the age reported by the seller, the covering is in the last few years of its service life.

**Recommendation:** Have the lifted and missing tabs repaired now to keep water out. Budget for full replacement within approximately two to five years, and obtain quotes before closing so the cost is known.

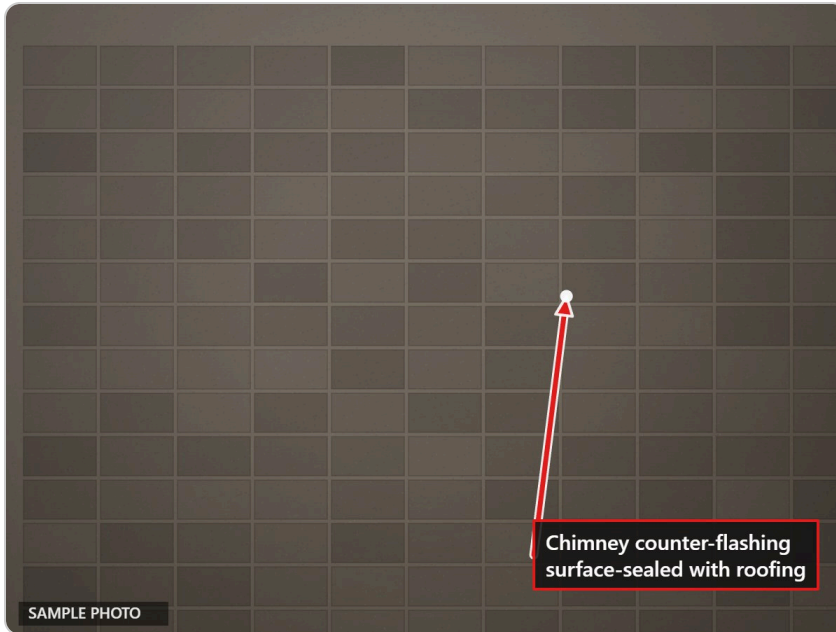
## Flashings

**Notes:** The chimney counter-flashing is surface-sealed with roofing cement rather than let into a reglet in the masonry, and the sealant has cracked and separated along the upslope side. Staining on the attic sheathing directly below this flashing confirms active entry.

**Recommendation:** Have a qualified roofer install proper step and counter-flashing let into the mortar joint. Roofing cement is a temporary measure and has already failed here.

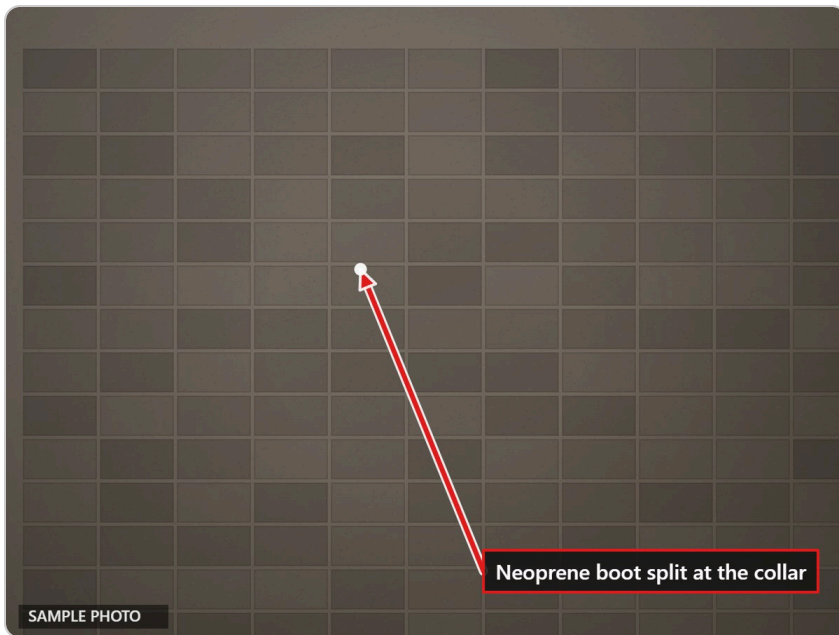
## Penetrations

**Notes:** The neoprene boot on the rear plumbing vent stack is cracked and split at the collar. These boots typically fail well before the shingles around them do.

**Recommendation:** Replace the vent boot. Inexpensive, and it prevents a leak that

would otherwise appear in a second-floor ceiling.

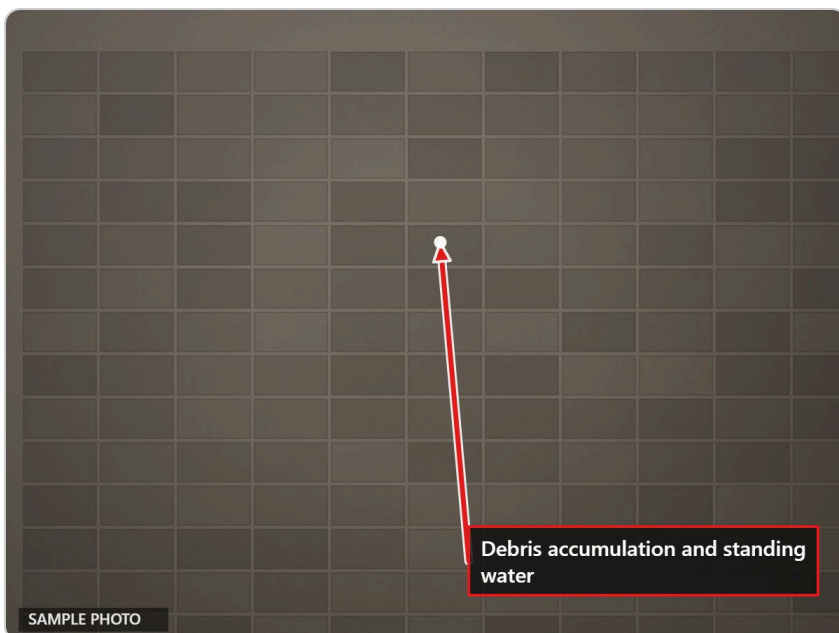
### Gutters

**Notes:** Gutters are loaded with leaf debris and granule sediment along the rear and left runs, and standing water was present in the rear run. Two hangers on the left run are pulled loose.

**Recommendation:** Clean the gutters and refasten the loose hangers. Establish a twice-yearly cleaning schedule given the mature trees on the property.

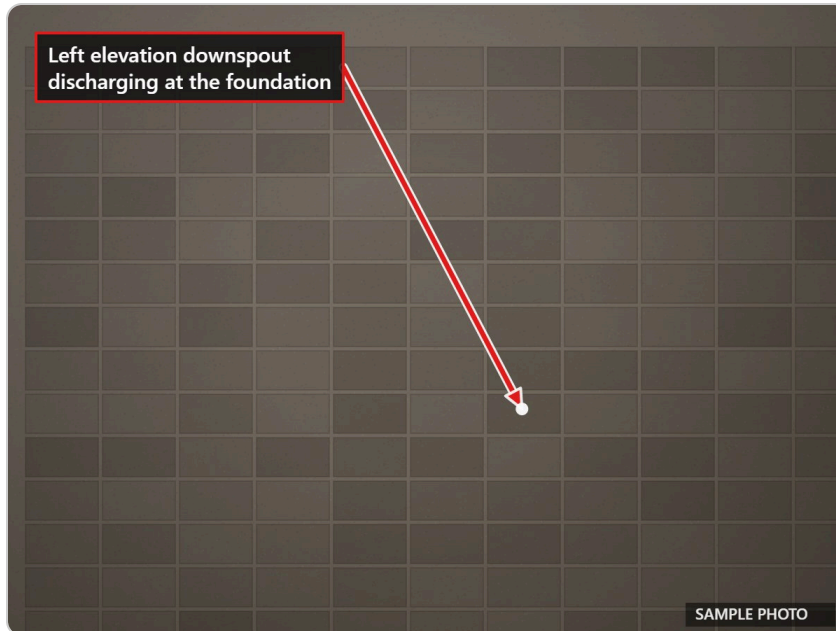
### Downspouts

**Notes:** Two downspouts discharge directly at the foundation with no extension or splash block. The left elevation downspout discharges into the area of negative grade described under Exterior.

**Recommendation:** Extend all downspouts a minimum of four to six feet from the foundation. This is the least expensive step available to address the basement moisture observed.

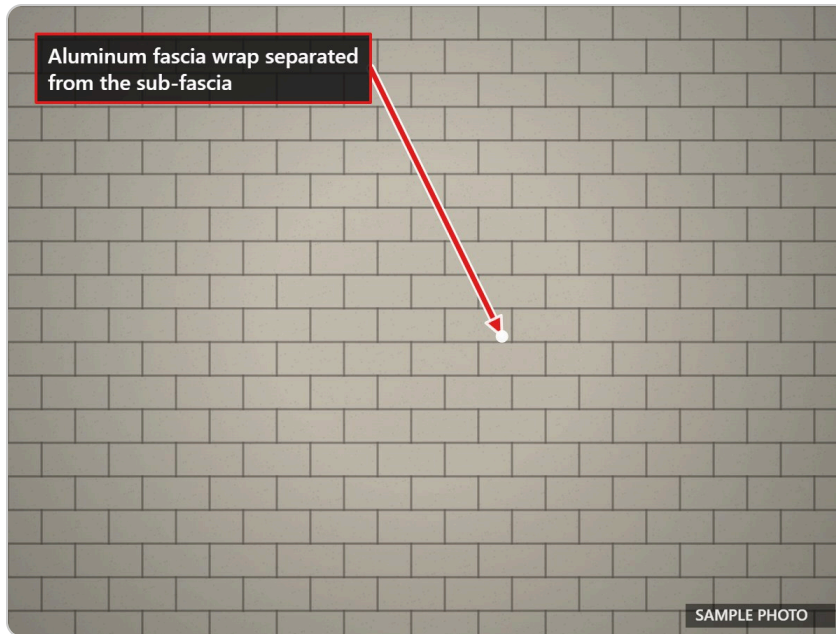
**Notes:** The aluminum-wrapped fascia above the rear deck is separated from the sub-fascia over an approximate six foot run, and the wrap has pulled away far enough to admit water and nesting activity. Staining on the sub-fascia behind the wrap indicates this has been open for more than one season.

**Recommendation:** Have a qualified carpenter reseal and refasten the fascia wrap, and replace any sub-fascia that has become soft. Correct before the next wet season.

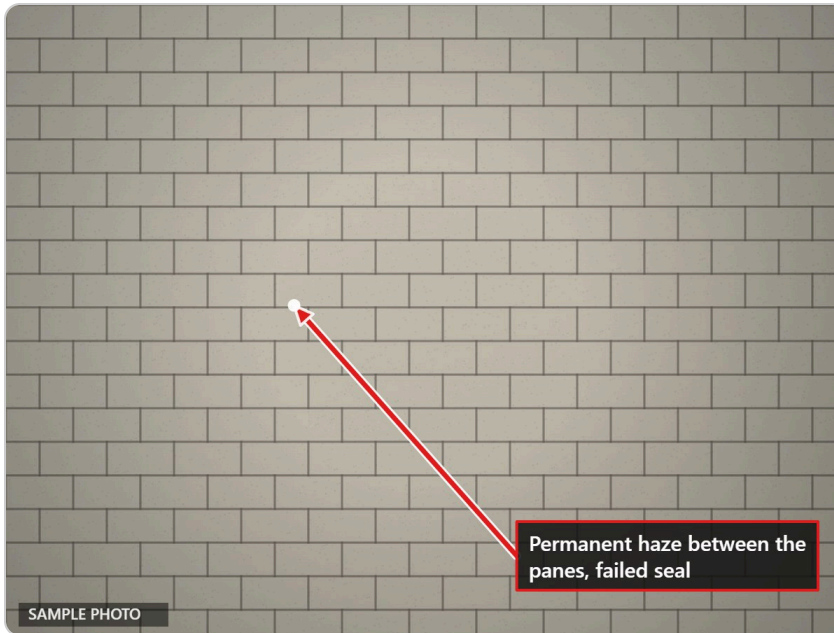
### Windows

**Notes:** The insulated glass unit at the front second-floor window shows a permanent haze and mineral deposit between the panes. The seal has failed. The window still operates and latches.

**Recommendation:** Plan to replace the failed insulated glass unit. A glass shop can

replace the sealed unit without replacing the whole window.

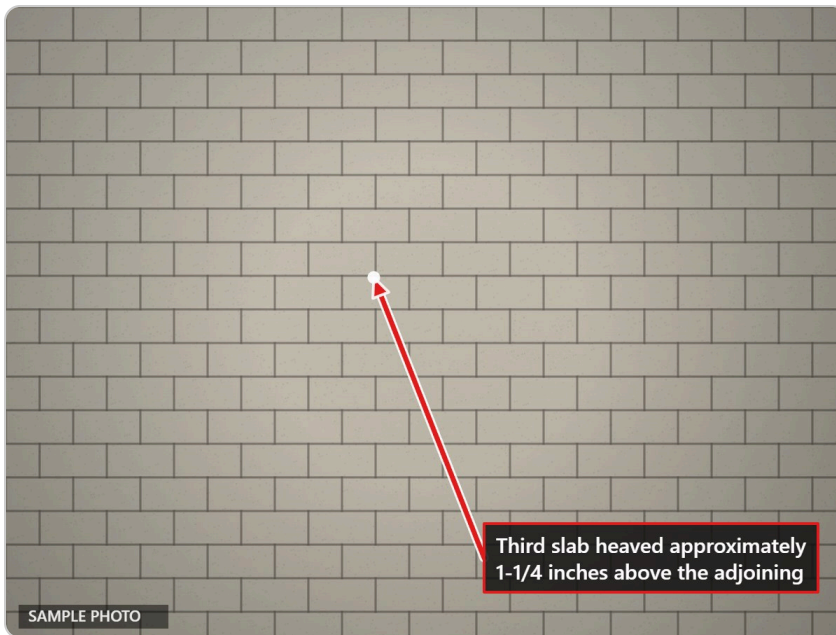
**Notes:** The third concrete slab in the front walk has heaved approximately one and one quarter inches above the adjoining slab, creating a raised edge across the full width of the walk. This is a trip hazard on the primary approach to the front door.

**Recommendation:** Have the slab ground down, mudjacked or replaced by a qualified concrete contractor. Until it is corrected, mark the edge so it is visible after

dark.

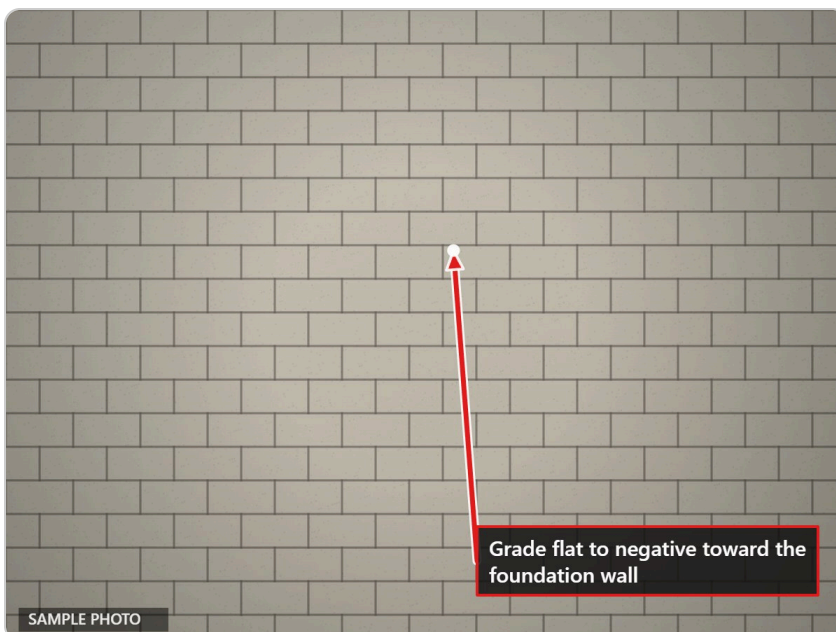
### Grading / Drainage

**Notes:** Grade along the left elevation is flat to slightly negative for approximately eighteen feet and directs surface water toward the foundation wall rather than away from it. Efflorescence on the interior of the basement wall on this elevation is consistent with this condition.

**Recommendation:** Regrade to fall a minimum of six inches over the first ten feet away from the foundation. Correcting the grade and the downspout discharge will address the basement moisture at its source.

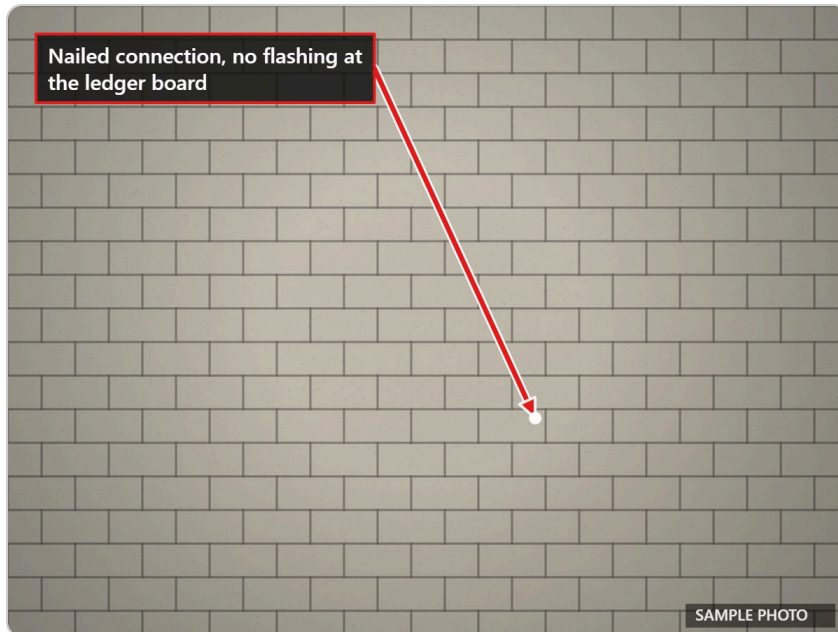
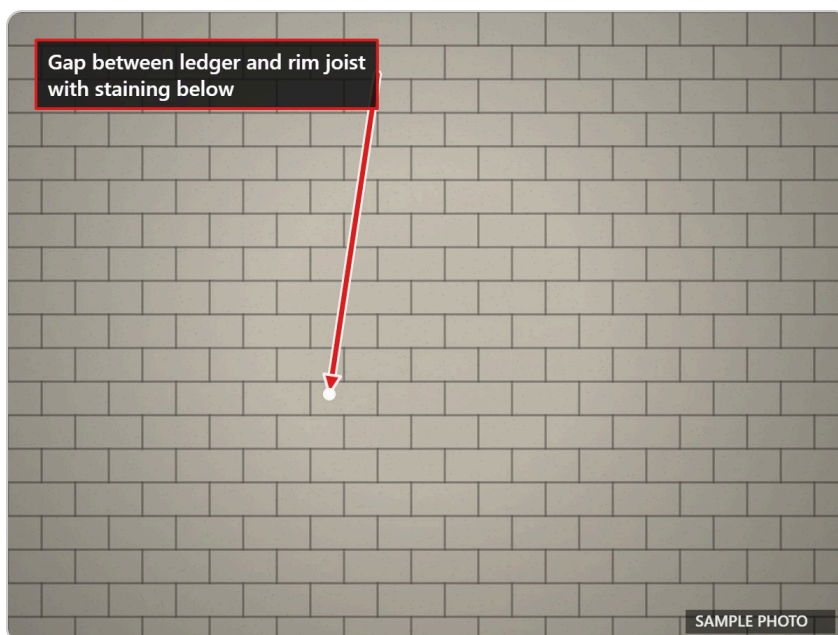
## Deck / Patio

**Notes:** The rear deck ledger is fastened to the house with nails rather than through-bolts or approved structural screws, and no flashing was observed at the ledger.

Nailed ledger connections are the most common cause of deck collapse, and the absence of flashing allows water into the rim joist behind the ledger.

**Recommendation:** This is a life-safety item. Have a qualified contractor retrofit an approved ledger connection and install proper flashing before the deck is loaded with people. Limit use of the deck until the repair is made.

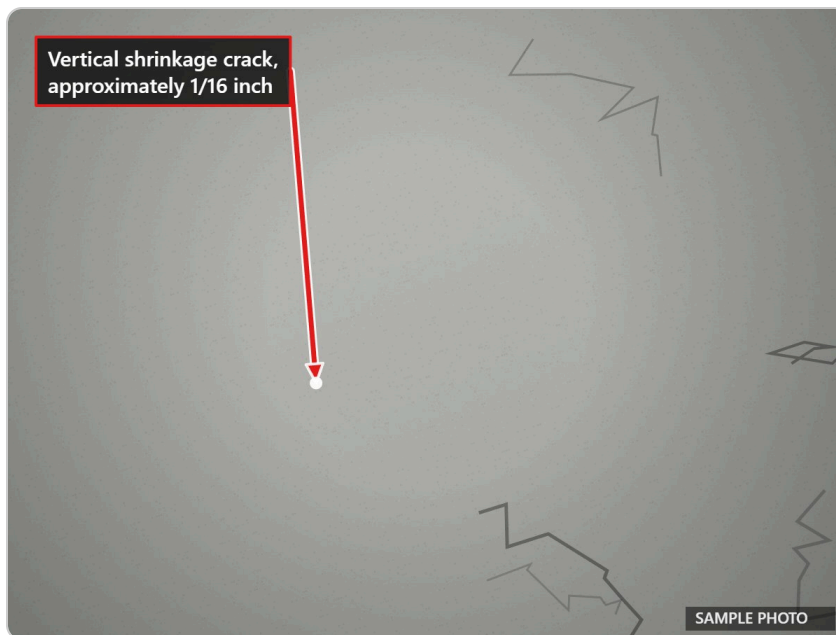
### Visible cracks / displacement

**Notes:** A vertical crack approximately one sixteenth of an inch wide runs from the top of the left foundation wall down about four feet. No lateral displacement, shearing or step cracking was observed. This pattern is typical of concrete shrinkage rather than movement.

**Recommendation:** Monitor. Seal the crack to keep water out, and if it widens beyond one eighth of an inch or begins to offset, have it evaluated by a structural engineer.

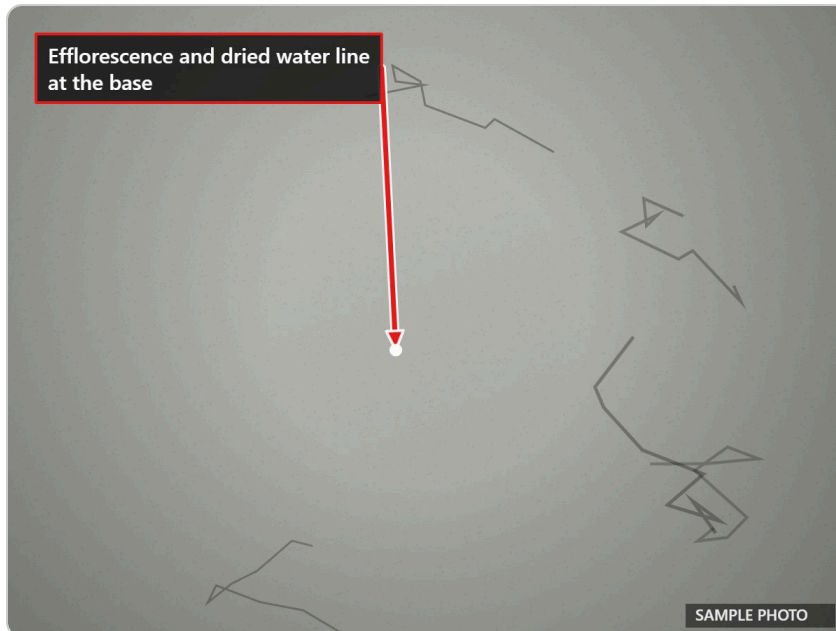
### Moisture / standing water (observed)

**Notes:** Efflorescence and a dried water line were observed along the base of the left foundation wall over approximately twelve feet. No standing water was present at the

time of the inspection. The pattern matches the negative grade and downspout discharge noted on this elevation.

**Recommendation:** Correct the exterior grading and downspout discharge first, then re-observe through one wet season before considering interior waterproofing. Most basements of this type are cured from outside at a fraction of the cost.

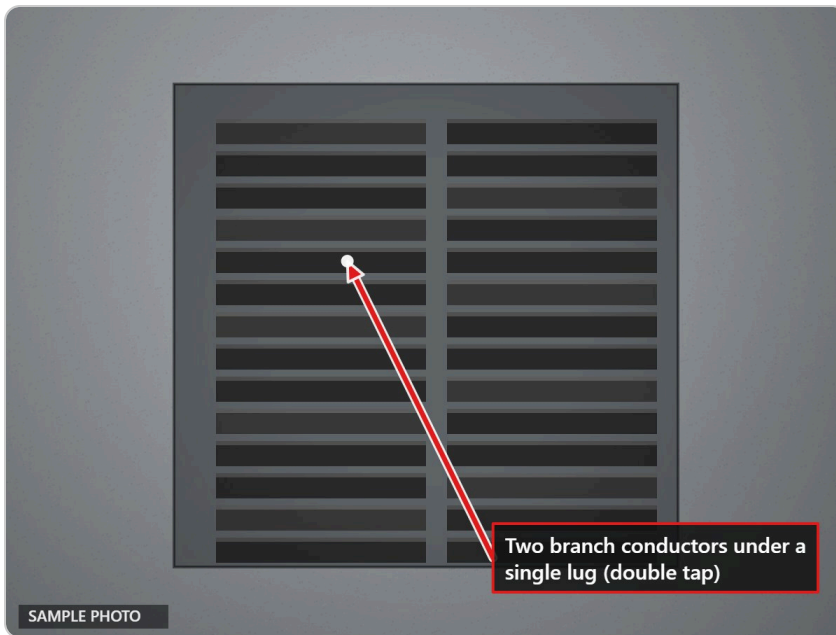
**Visible defects**

**Notes:** Two breakers are double-tapped, each carrying two branch circuit conductors under a single lug rated for one. Double tapping is a loose-connection and overheating risk and is among the most common defects found in a panel of this age.

**Recommendation:** Have a licensed electrician separate the double-tapped conductors onto their own breakers or install approved tandem breakers where the

panel permits.

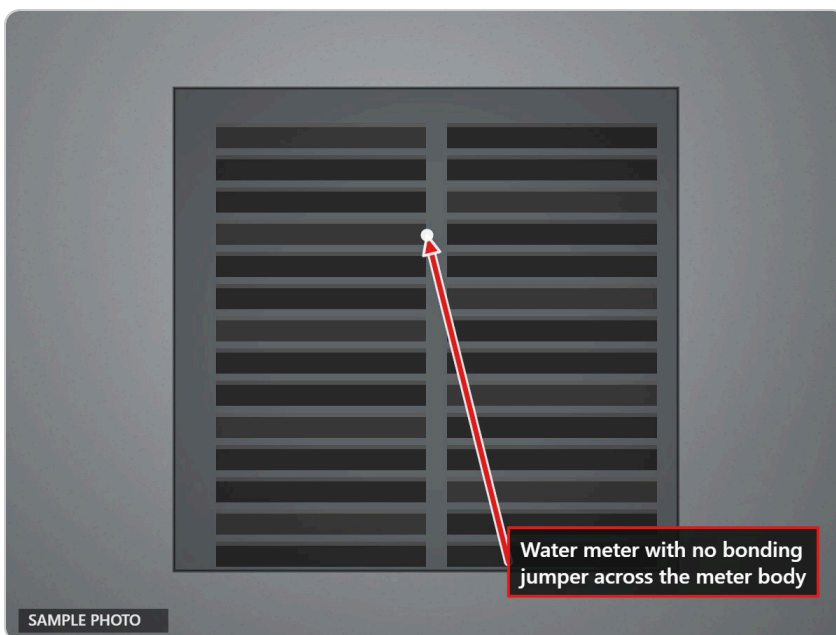
### Grounding / Bonding (observed)

**Notes:** The bonding jumper at the water meter is missing, leaving the two sides of the metallic water piping unbonded across the meter. A jumper is required so that the piping remains a continuous grounded path when the meter is removed for service.

**Recommendation:** Have a licensed electrician install an approved bonding jumper across the water meter.

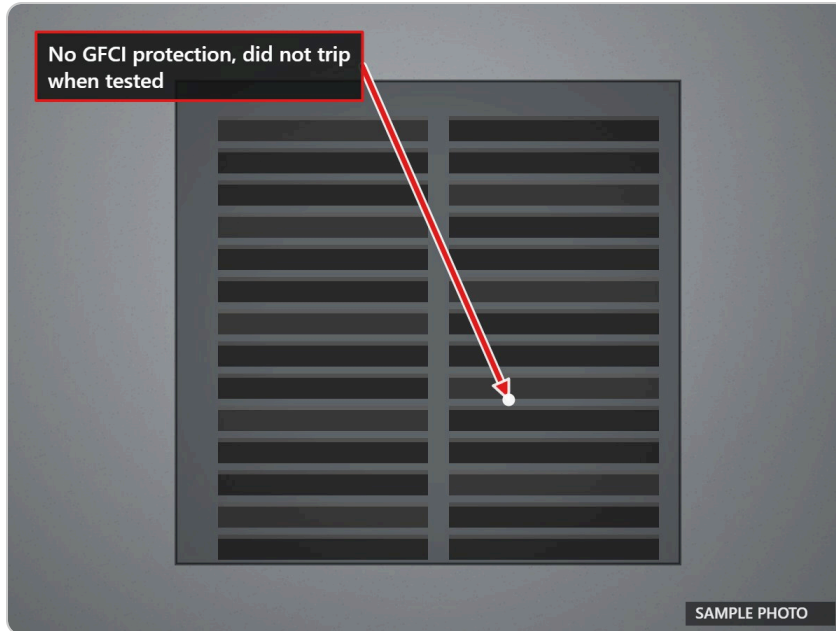
### **GFCI / AFCI (observed)**

**Notes:** GFCI protection is present and tested functional at the kitchen counter receptacles and at both exterior receptacles. The powder room receptacle and the basement receptacles are not GFCI protected and did not trip when tested.

**Recommendation:** Have a licensed electrician extend GFCI protection to the powder room and the basement receptacles.
