**LIBERTY RIDGE**

# Commercial Property Inspection Report

**Property:** 1180 Commerce Parkway, Mount Laurel, NJ 08054

**Date:** 2026-09-24

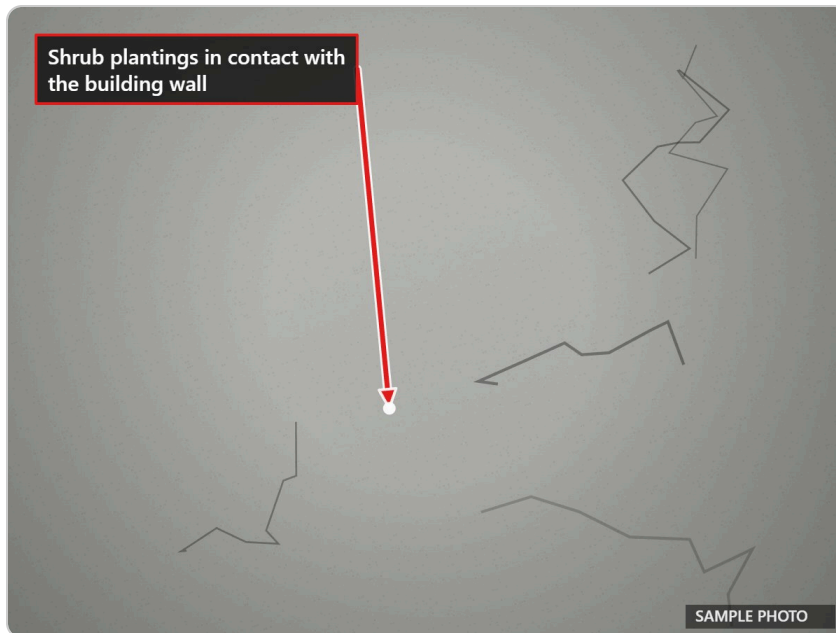
**Notes:** Shrub plantings along the south and west elevations are overgrown and in contact with the building wall over approximately sixty feet, holding moisture against the masonry and obscuring the base of the wall from view. Two trees at the northwest corner have limbs over the roof edge.

**Recommendation:** Cut plantings back to a minimum of eighteen inches clear of the wall and trim the limbs clear of the roof. Overhanging limbs drop debris into the roof drains that are already obstructed.

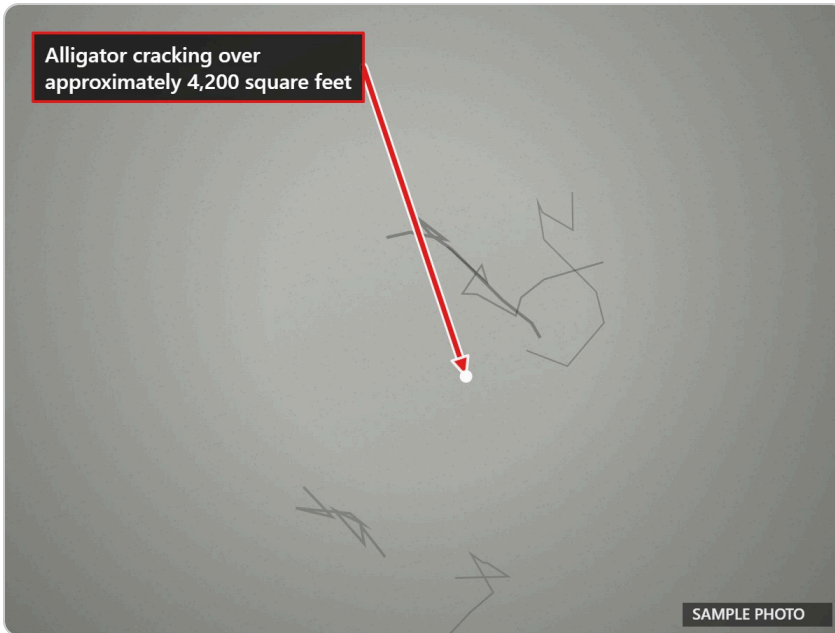
**Notes:** Asphalt across the north lot shows extensive alligator cracking over approximately 4,200 square feet, with three potholes exceeding four inches in depth near the east drive aisle. The east lot is in materially better condition and appears to have been overlaid more recently.

Alligator cracking over  
approximately 4,200 square feet

**Recommendation:** Mill and overlay the north lot and patch the potholes. Obtain unit pricing during diligence; at this extent the work is a capital item rather than maintenance and should be priced into the acquisition.

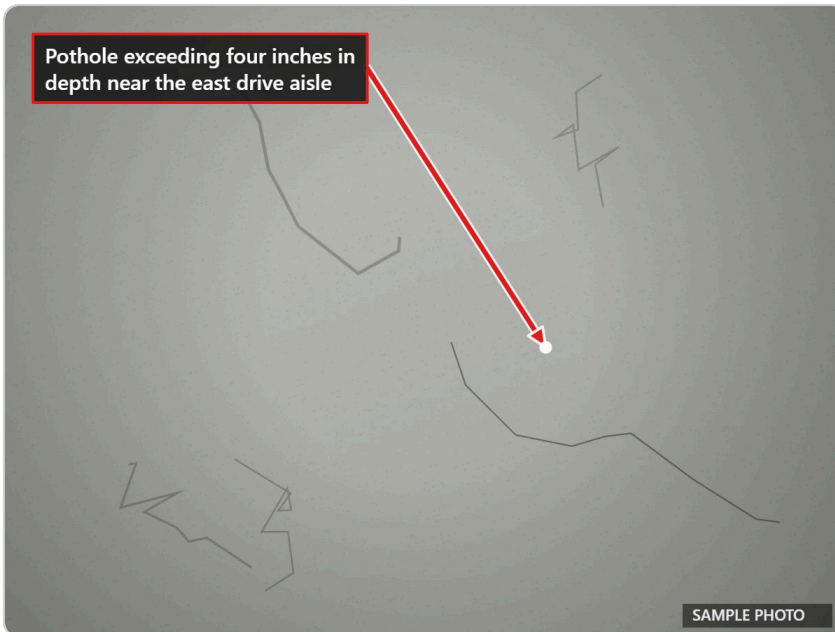
Pothole exceeding four inches in  
depth near the east drive aisle

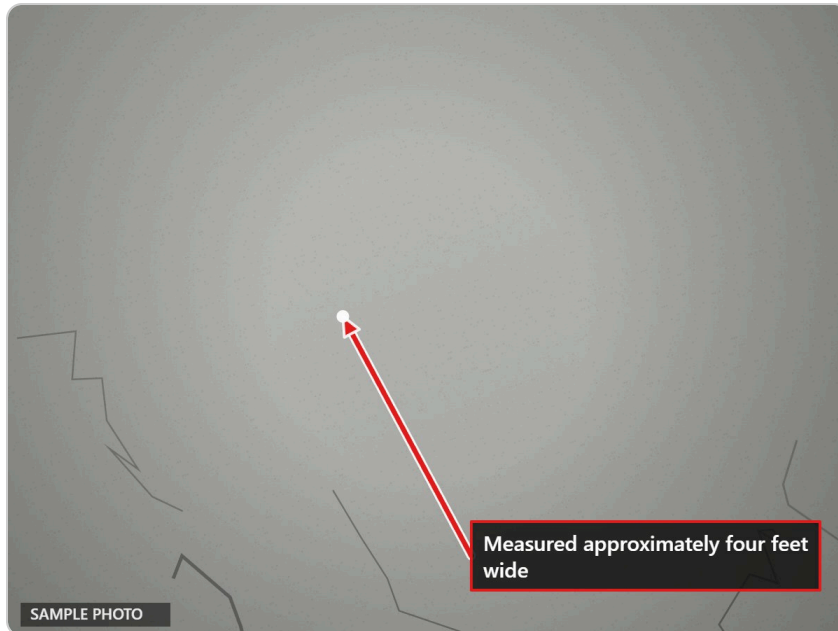
**Notes:** Four accessible spaces are provided. The access aisle serving spaces 3 and 4 measures approximately four feet wide against the five foot minimum, and no van-accessible space with an eight foot aisle is provided anywhere on the site. Two of the four signs are mounted below the required sixty inch bottom-of-sign height.

**Recommendation:** This is an accessibility compliance exposure that transfers with the property. Have the spaces, aisles and signage brought into conformance as part of the restriping, and have a qualified accessibility consultant review the full site if tenant mix will change.

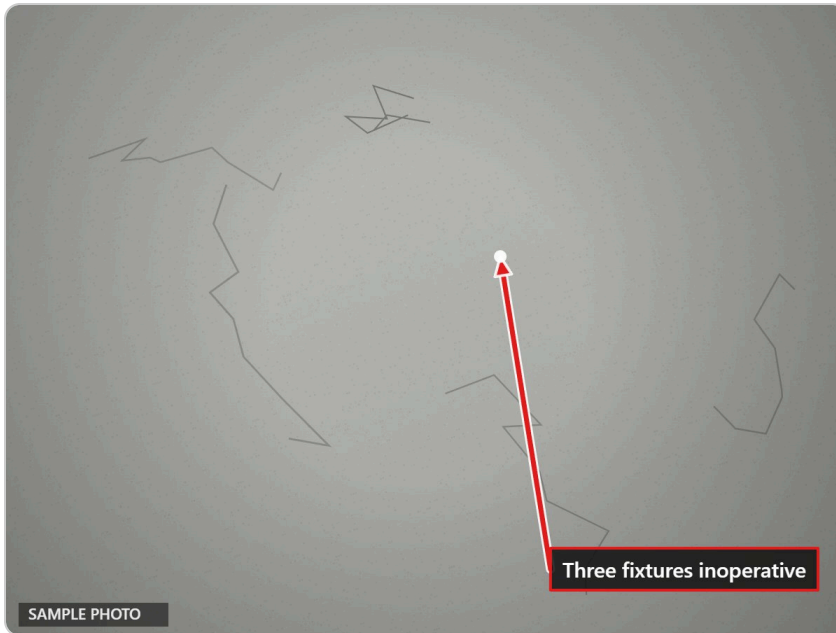
**Notes:** Three of eleven pole-mounted fixtures were inoperative during the evening return visit, leaving the northwest quadrant of the lot substantially dark. One pole shows corrosion at the base plate and the handhole cover is missing.

**Recommendation:** Restore the inoperative fixtures and have the corroded pole

base evaluated. Lot lighting is a premises-liability item for a multi-tenant property.

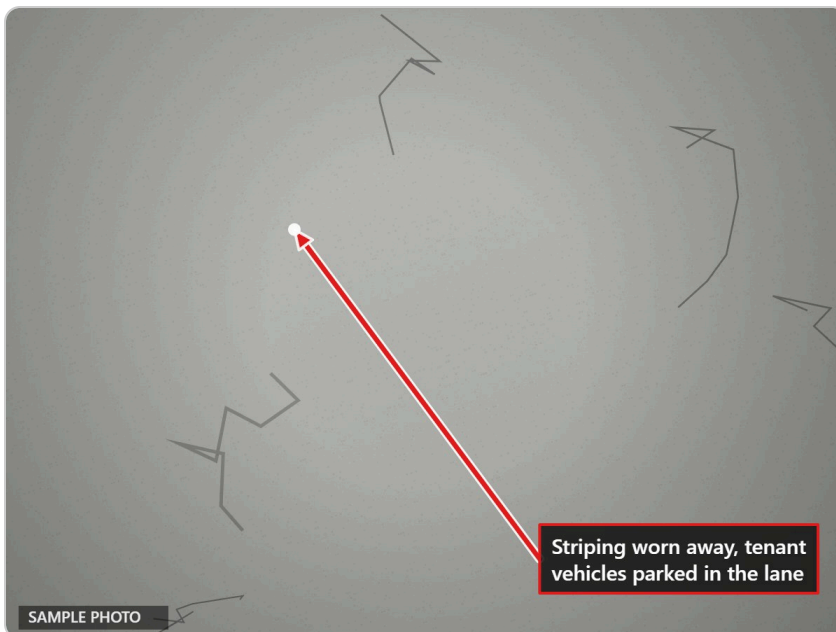
**Notes:** Fire lane striping along the south face is largely worn away and two tenant vehicles were parked within the lane during the inspection. Overhead clearance is unobstructed.

**Recommendation:** Restripe and re-sign the fire lane and address enforcement through the tenant leases.

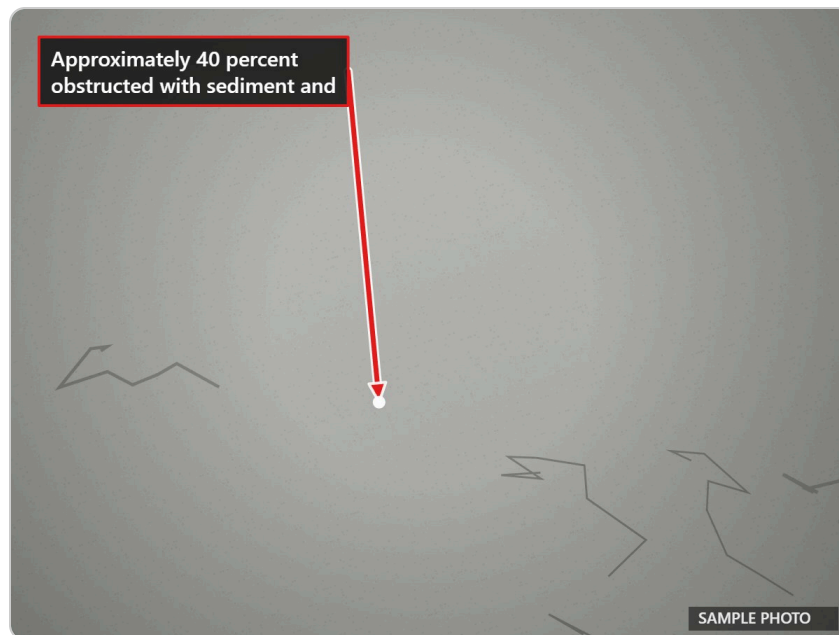
**Notes:** The detention basin outlet structure is approximately forty percent obstructed with sediment and vegetation, and the emergency spillway is overgrown. Standing water was present three days after the last recorded rainfall.

**Recommendation:** Have the basin cleaned and the outlet structure cleared, and confirm whether a maintenance agreement with the township is recorded against the property.

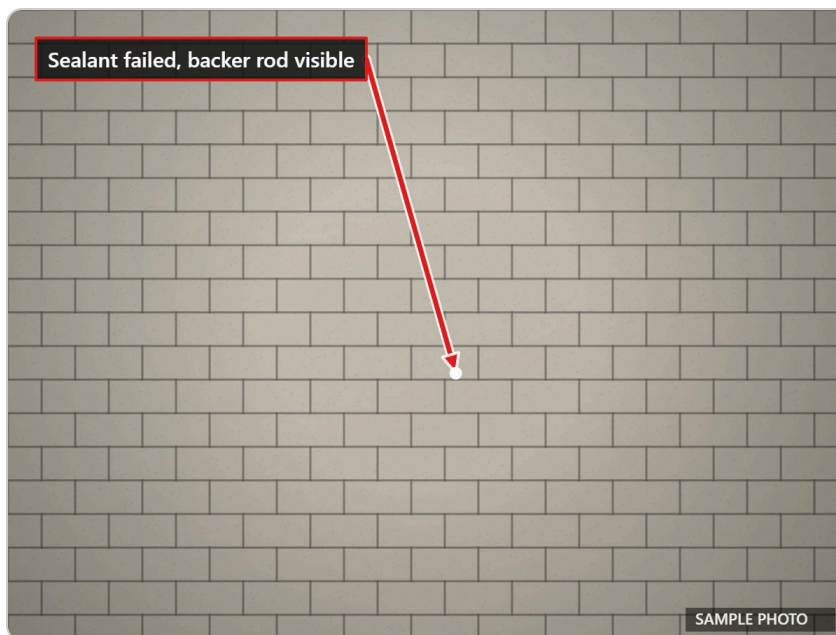
**Notes:** Sealant at the vertical control joints on the south elevation has failed over approximately sixty percent of its length, with the backer rod visible and in places missing. Open joints on a masonry wall admit water into the cavity and are the usual cause of interior efflorescence.

**Recommendation:** Have the joints cleaned, backer rod replaced and resealed with a compatible sealant. This is routine maintenance that has been deferred.

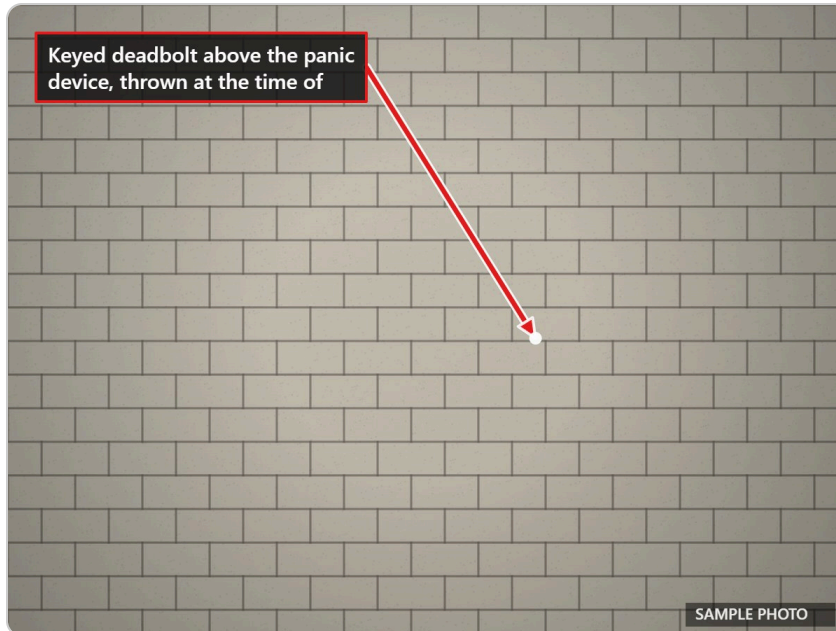
**Notes:** The rear egress door serving Suite C is fitted with a keyed deadbolt above the panic device, and the deadbolt was thrown at the time of the inspection. This requires a key to exit and defeats the egress path for the occupied suite.

**Recommendation:** Remove the deadbolt immediately. This is a life-safety violation and the most serious condition found on this property. Confirm with the fire official and correct in every suite.

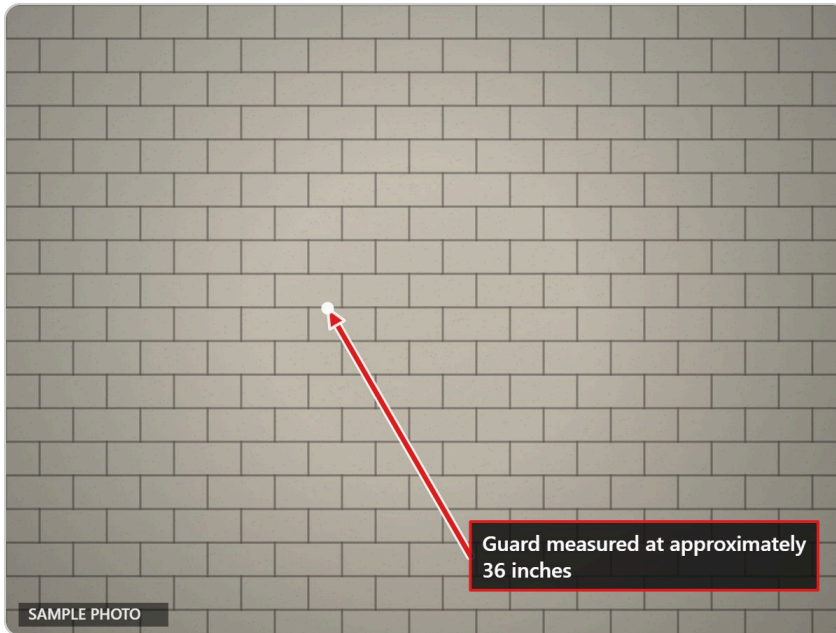
**Notes:** The guard at the Suite D rear landing measures approximately thirty six inches where forty two inches is required for a commercial guard, and the intermediate rail is loose at two connections.

**Recommendation:** Have the guard raised to a conforming height and the

connections secured.

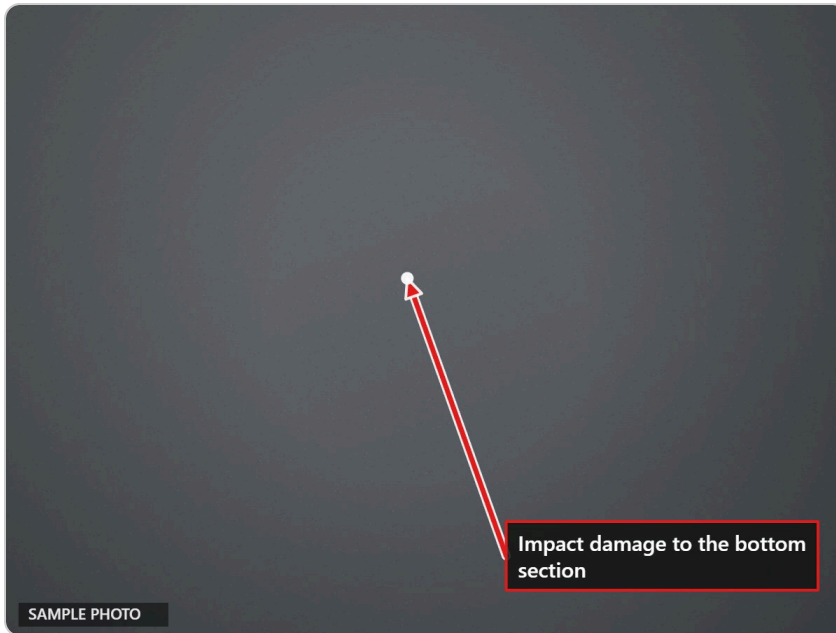
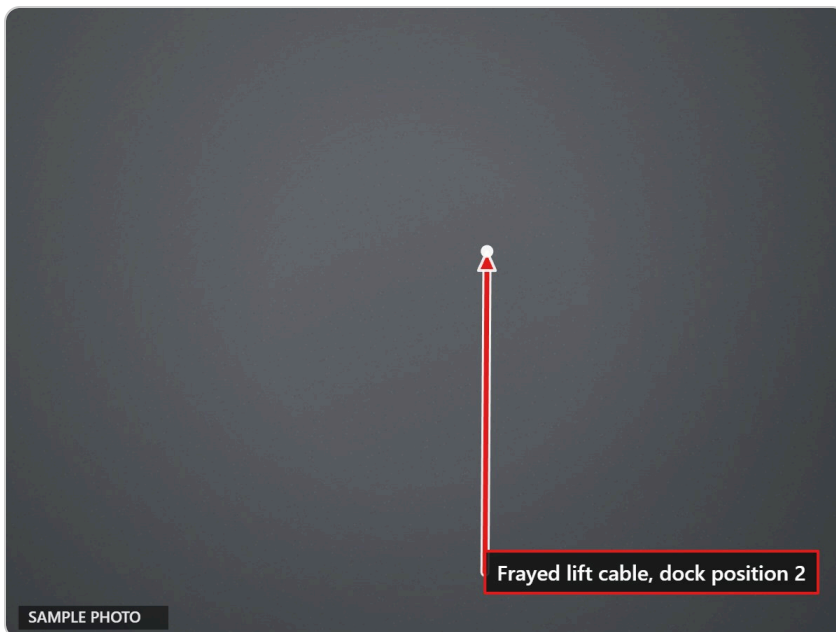
**Notes:** Six manual overhead dock doors. Two have damaged bottom sections from impact, one has a frayed lift cable and two have panels that bind in the track. All six operate with effort.

**Recommendation:** Have a qualified overhead door contractor service all six doors and replace the frayed cable immediately. A failing lift cable on a door this size is a crush hazard.

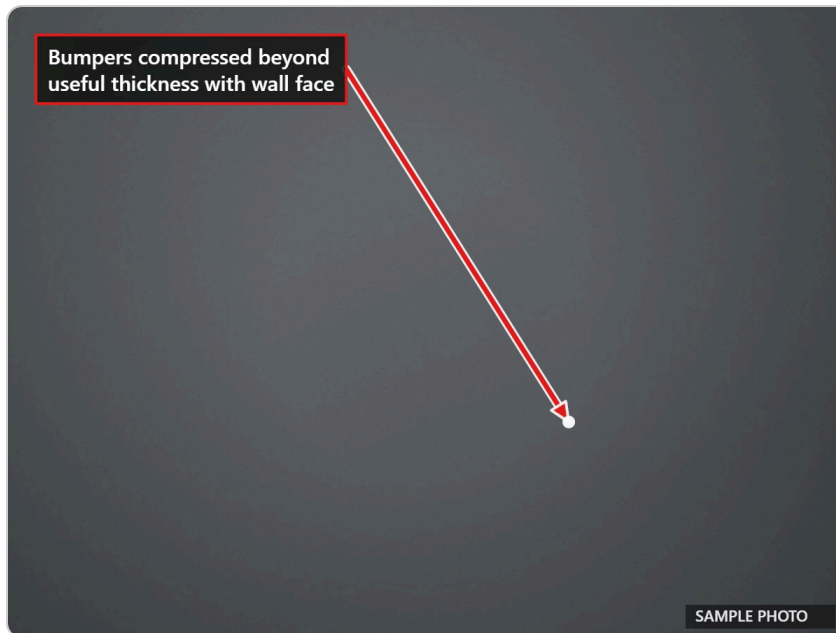
**Notes:** Bumpers at four of six positions are compressed beyond useful thickness or missing entirely. Impact damage to the wall face is already visible at position 4.

**Recommendation:** Replace the bumpers. They cost a fraction of the wall repair they prevent.

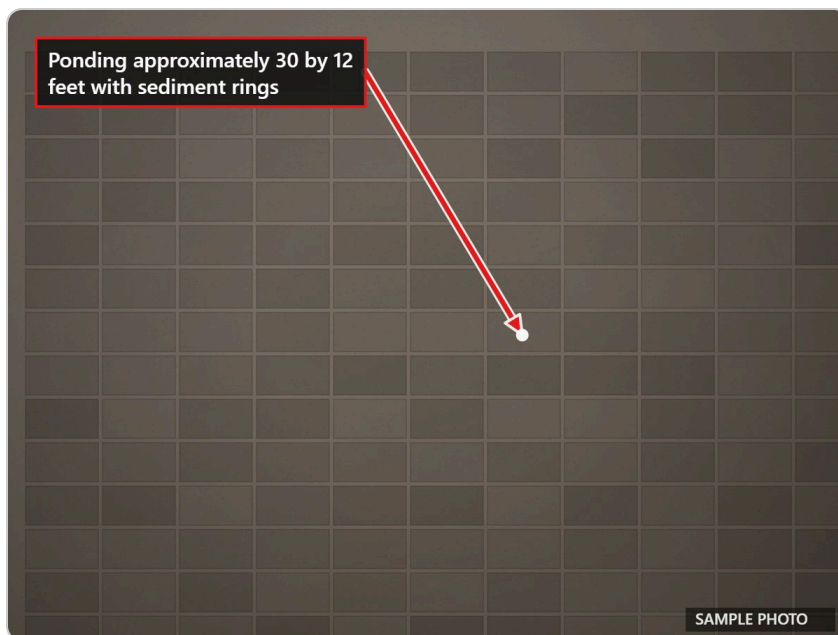
**Notes:** Two ponding areas were observed holding water more than forty eight hours after rainfall, the larger approximately thirty by twelve feet with visible sediment rings indicating a long-standing condition. Ponding accelerates membrane failure and adds unplanned dead load.

**Recommendation:** Add roof drains or taper insulation crickets to move water to

drainage. Address at the same time as the seam repairs.

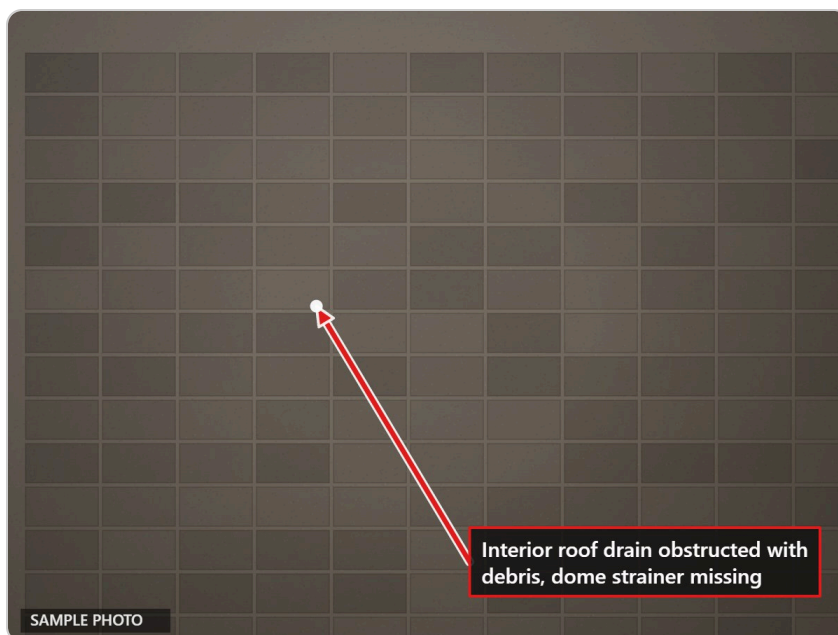
**Notes:** Two of four interior roof drains are obstructed with debris and one is missing its dome strainer entirely. A drain without a strainer will eventually pass debris into the leader and block it inside the building.

**Recommendation:** Clear all four drains, fit a strainer at the missing location and put the roof on a semi-annual maintenance schedule.

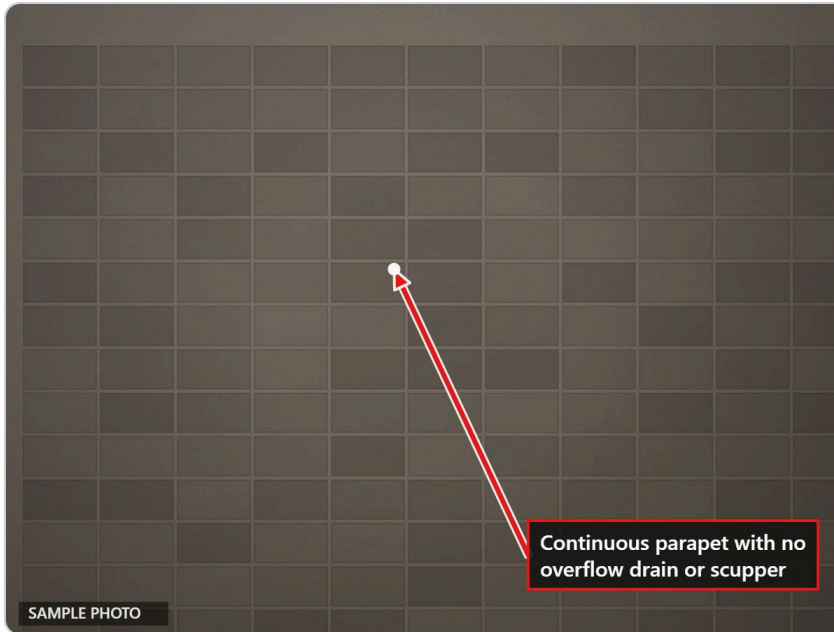
**Notes:** No overflow drains or overflow scuppers were observed anywhere on this roof. With the parapet continuous on all four sides and the primary drains already prone to blockage, a blocked drain during a heavy rain has no secondary path and the water load accumulates on the structure.

**Recommendation:** Have a design professional evaluate and provide overflow drainage. Read together with the ponding and blocked drains, this is a structural loading concern and not merely a roofing one.

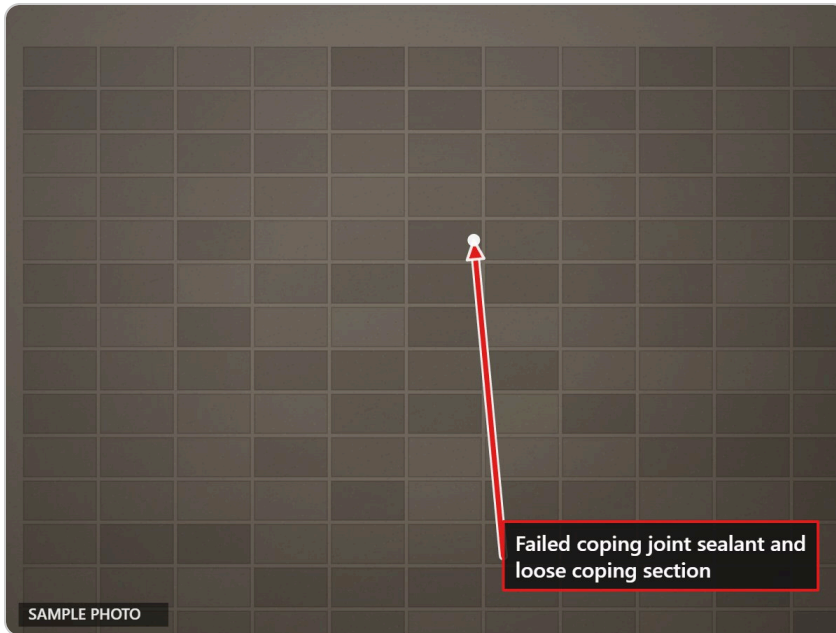
**Notes:** Coping joint sealant has failed over much of the north and west parapets and two coping sections are loose. Open coping joints admit water directly into the wall cavity behind the membrane termination.

**Recommendation:** Reset the loose sections and reseal the coping joints.

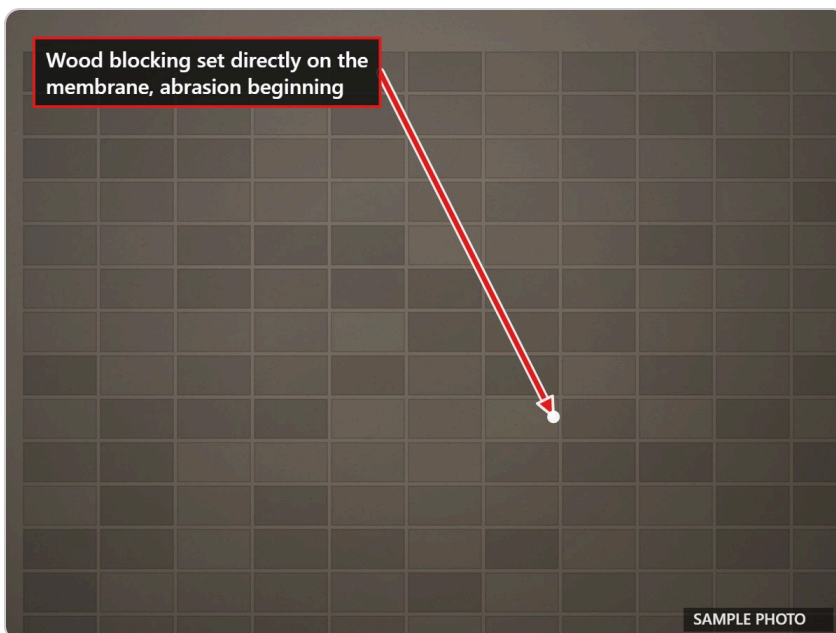
**Notes:** Pipe and conduit supports on the roof are wood blocking set directly on the membrane at several locations, and two blocks have begun to abrade the membrane beneath them.

**Recommendation:** Replace the wood blocking with proper pipe supports bearing on walk pads.

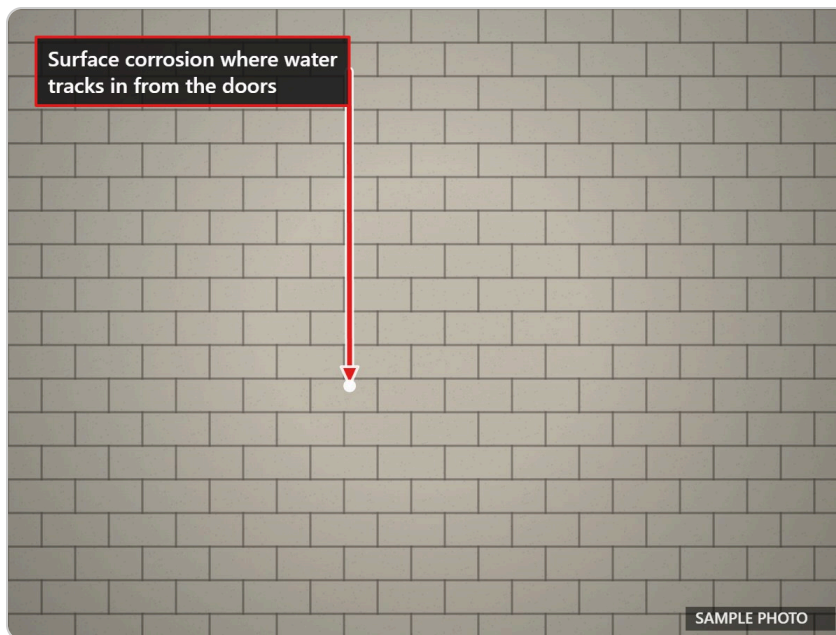
**Notes:** Open web steel joists with a steel column grid. Surface corrosion was observed at the base of two columns in the dock area where water tracks in from the doors. No section loss or deflection was observed.

**Recommendation:** Clean and repaint the affected column bases and address the water entry at the dock doors.

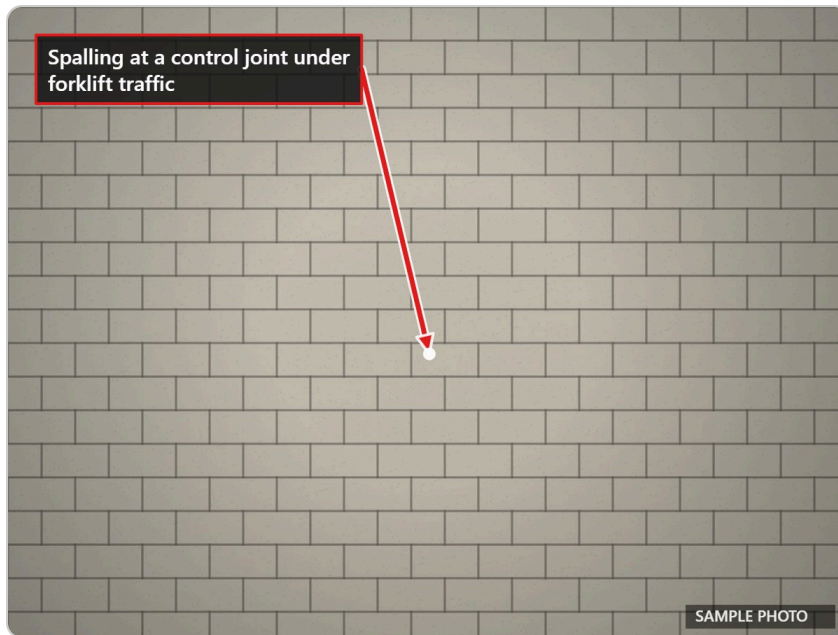
**Notes:** Typical shrinkage cracking with spalling at several control joints under forklift traffic. No differential settlement across the joints was measured.

**Recommendation:** Fill and armor the spalled joints to prevent further edge

breakdown under wheel loads.

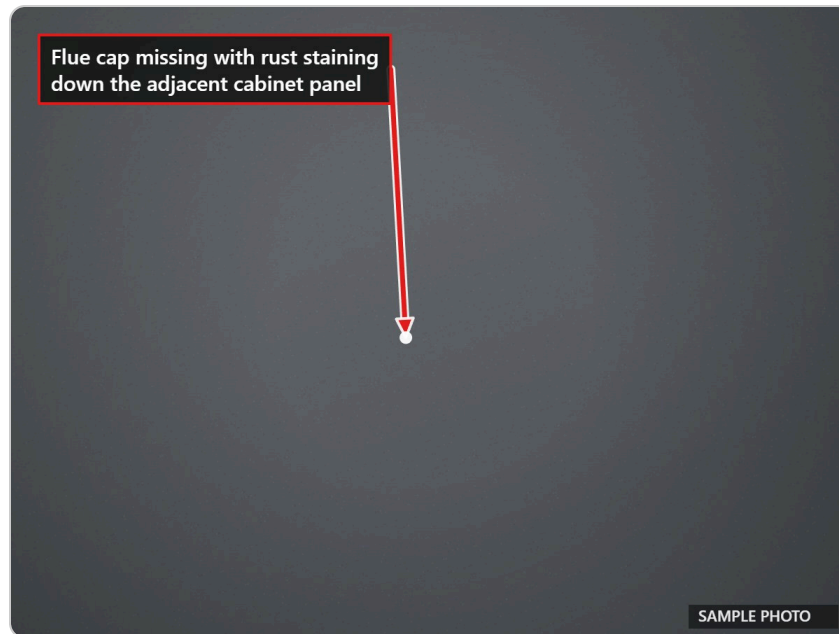
**Notes:** The flue cap on RTU-3 is missing and rust staining is visible down the

adjacent cabinet panel.

**Recommendation:** Have the flue cap replaced and the heat exchanger evaluated by a licensed contractor given the evidence of water entry.

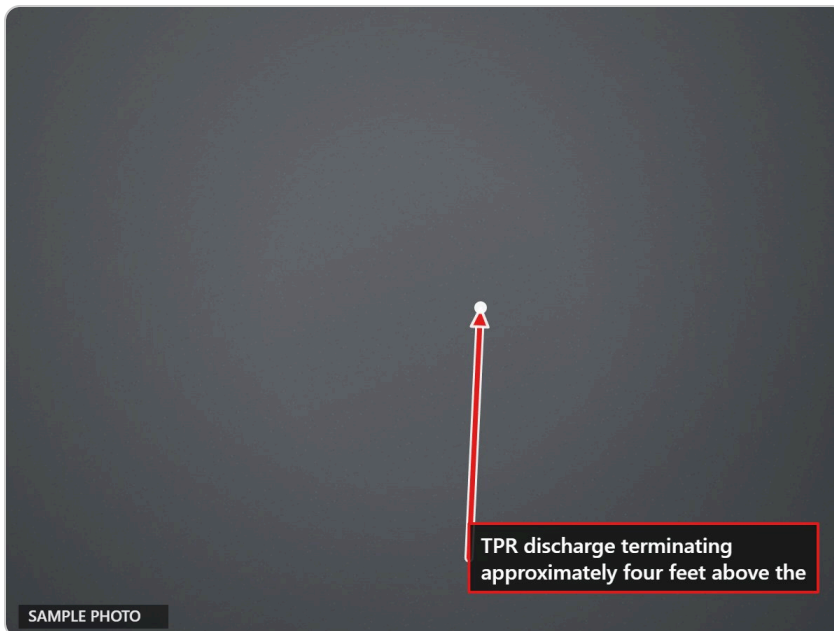
**Notes:** The temperature and pressure relief discharge terminates approximately four feet above the floor and is reduced in diameter at the last fitting.

**Recommendation:** Have a licensed plumber run a full-size discharge terminating within six inches of the floor.

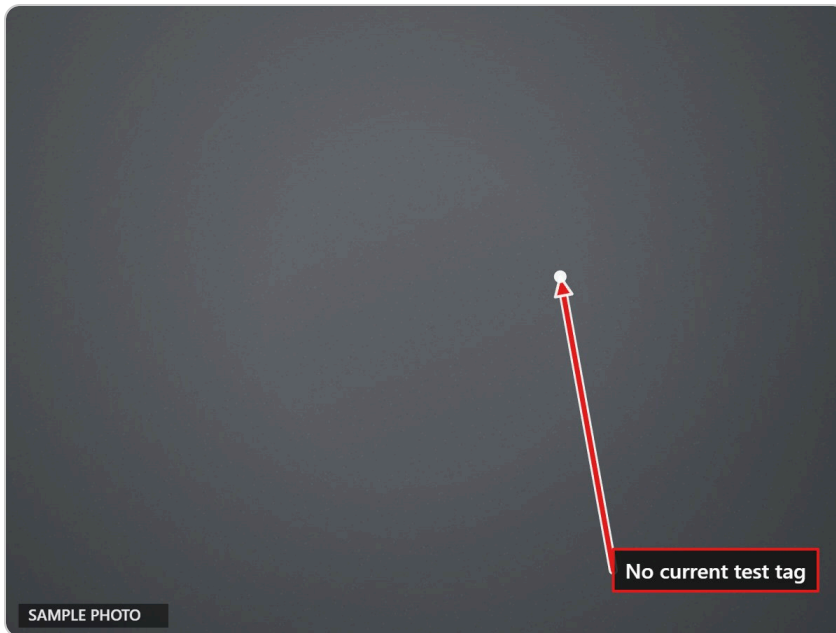
**Notes:** A reduced pressure zone assembly is present on the domestic service. No current test tag was found on either the domestic or the fire service assembly. Annual testing is required in New Jersey.

**Recommendation:** Have both assemblies tested and tagged by a certified tester and obtain the test history during diligence.

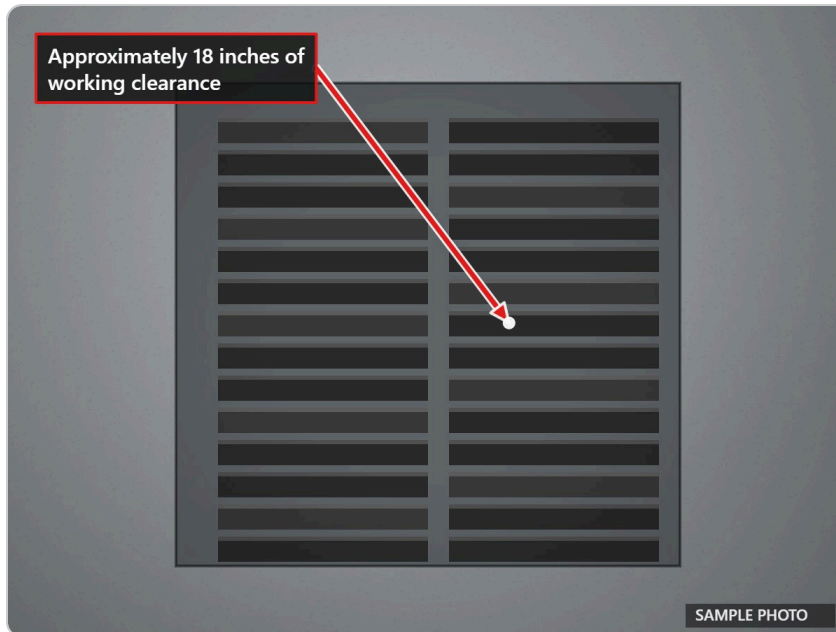
**Notes:** Tenant stored material is stacked against the distribution panel, leaving approximately eighteen inches of working clearance where thirty six inches is required in front of energized equipment. An electrician cannot safely work this panel, and in an emergency it cannot be reached.

**Recommendation:** Clear and permanently mark the working space with floor striping. Address storage through the tenant lease. This is an immediate correction, not a scheduled one.

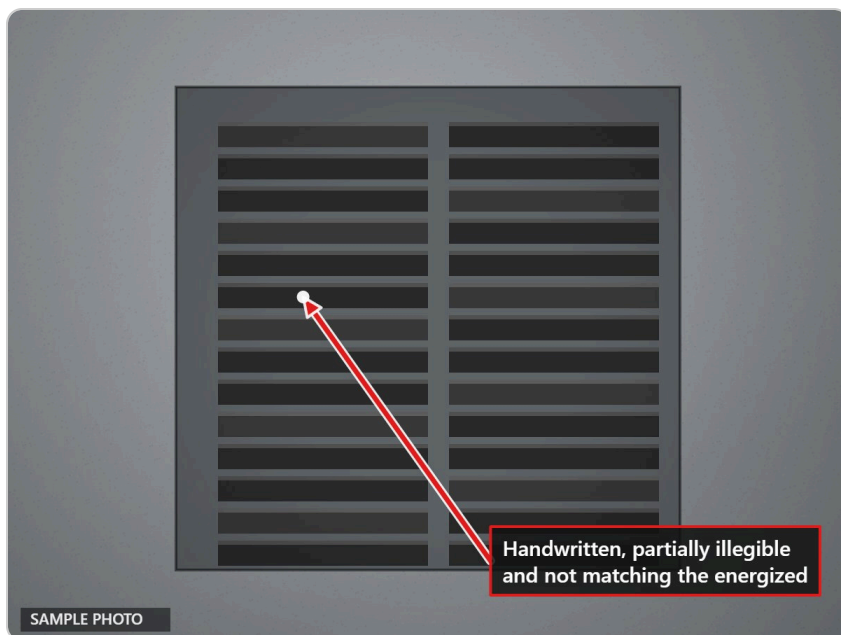
**Notes:** Circuit directories at three of four subpanels are handwritten, partially illegible and do not correspond to the circuits energized during testing. Unlabeled panels in a multi-tenant building mean the wrong tenant gets shut down during a repair.

**Recommendation:** Have a licensed electrician circuit-trace and relabel all panels

with typed, durable directories.

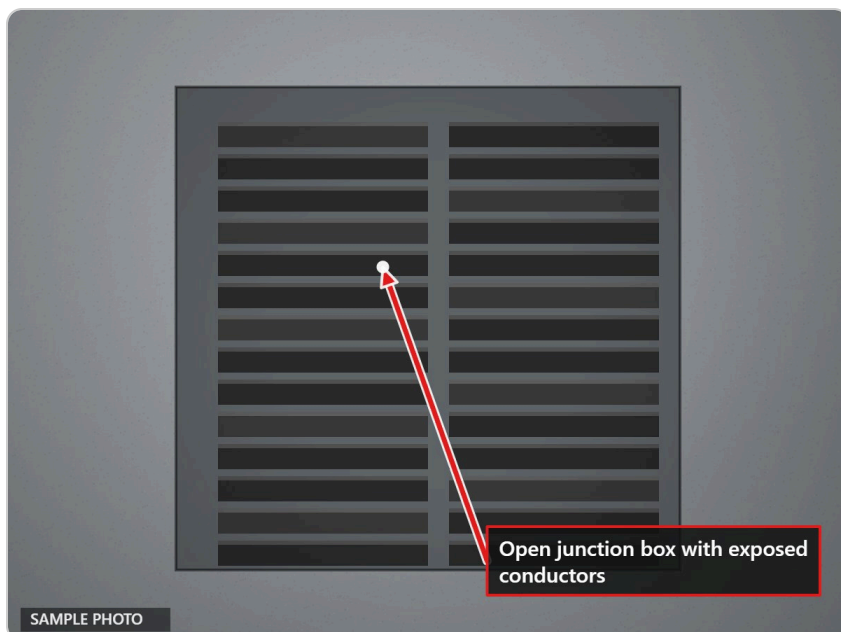
**Notes:** Four junction boxes in the Suite C warehouse ceiling are open with conductors exposed, and one box has a cable entering with no connector and the sheathing cut back beyond the box.

**Recommendation:** Have a licensed electrician fit covers and proper connectors at every location. Exposed conductors overhead in an occupied warehouse are a shock and arc hazard.

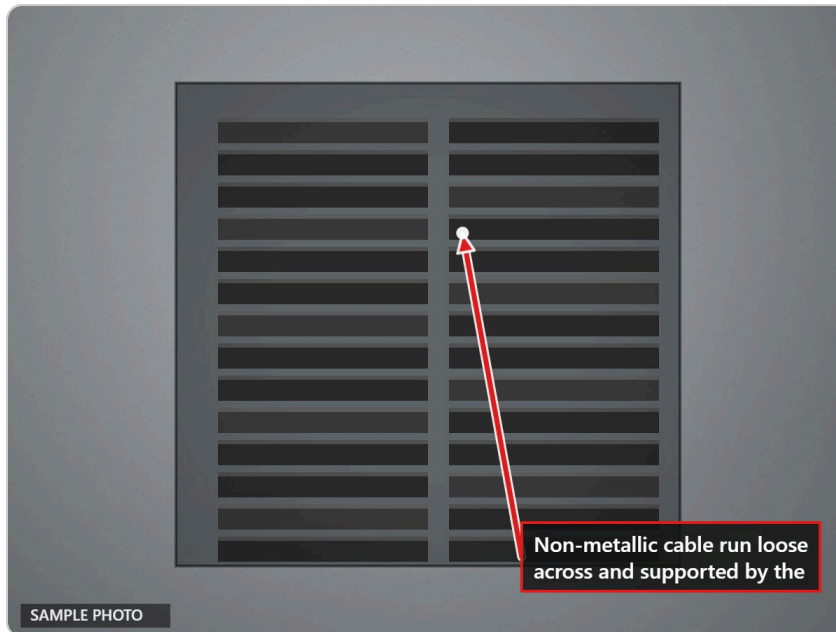
**Notes:** Non-metallic sheathed cable is run loose across the suspended ceiling grid and supported by the tiles in Suite D, terminating at two unsupported surface boxes. This is an unpermitted tenant alteration.

**Recommendation:** Have a licensed electrician remove or properly install and support this wiring, in raceway where required. Obtain the permit history for the Suite D fit-out during diligence.

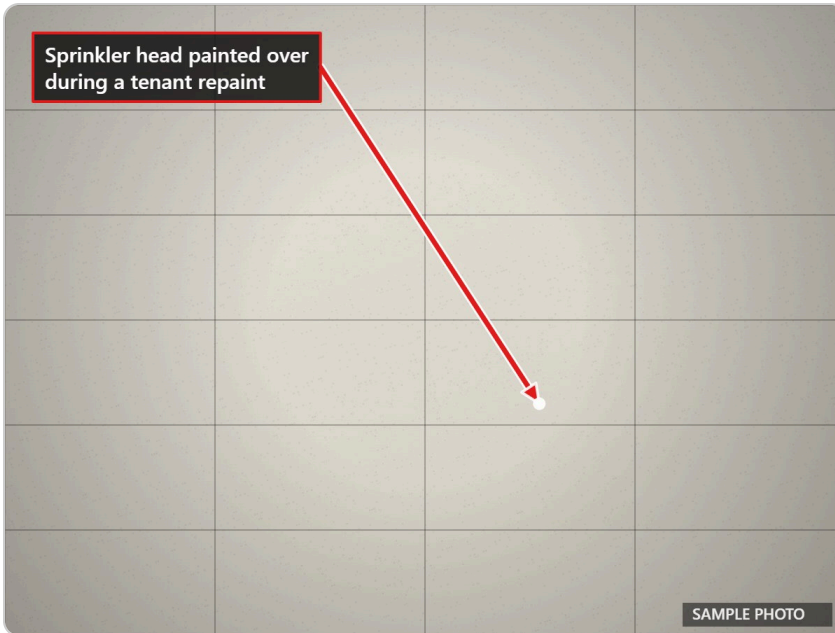
**Notes:** Eleven sprinkler heads in Suite C are painted over from a tenant repaint, and storage in Suite D is stacked within twelve inches of the deflectors across two racking rows. A painted head does not operate at its rated temperature, and obstructed heads cannot develop their spray pattern. No spare head cabinet was found at the riser.

Sprinkler head painted over  
during a tenant repaint

**Recommendation:** Have a licensed fire protection contractor replace every painted head, enforce the eighteen inch clearance below deflectors through the leases, and provide a spare head cabinet and wrench at the riser. Read with the tag finding below, this system is not in a condition to be relied on.

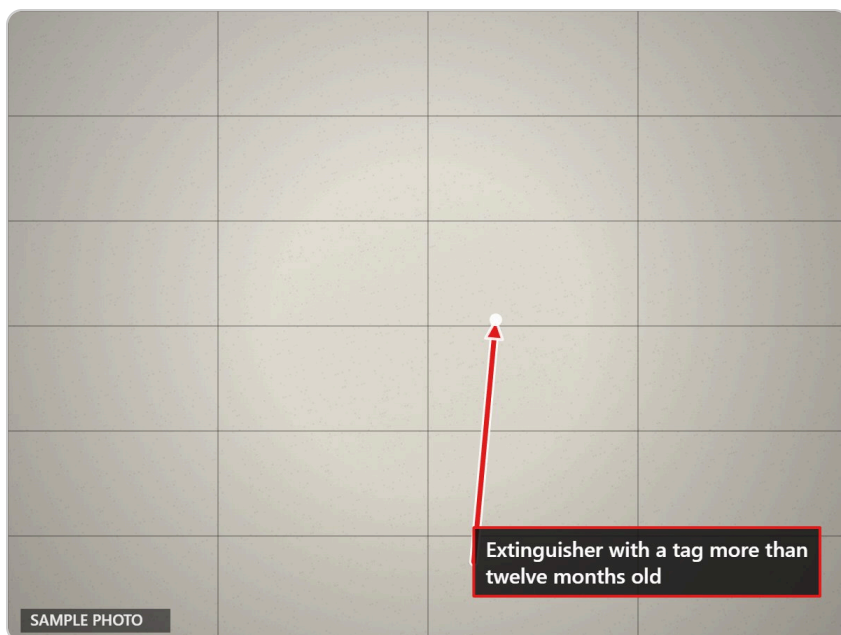
**Notes:** Nine extinguishers were located. Six carry tags more than twelve months old, two are missing from their marked brackets and one in Suite B shows a gauge in the recharge range.

**Recommendation:** Have all units serviced and tagged annually and replace the missing units. Mark every location so a missing unit is visible.

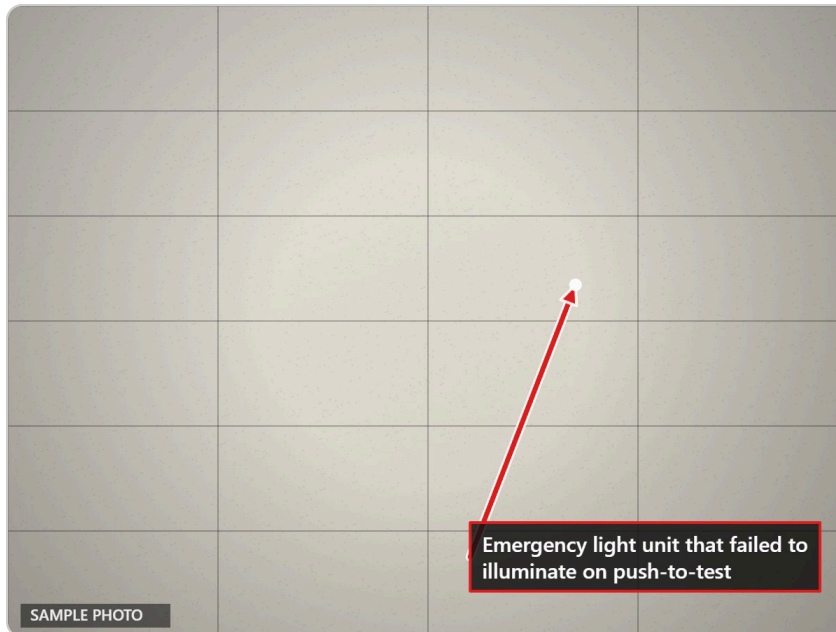
**Notes:** Of fourteen emergency light units tested by the push-to-test button, five failed to illuminate and two illuminated at visibly reduced output. Battery-backed units fail silently and are only found by testing.

**Recommendation:** Have every unit tested, batteries replaced and a monthly test and annual ninety minute test log established. This is required and it is also the thing that gets people out of a dark warehouse.

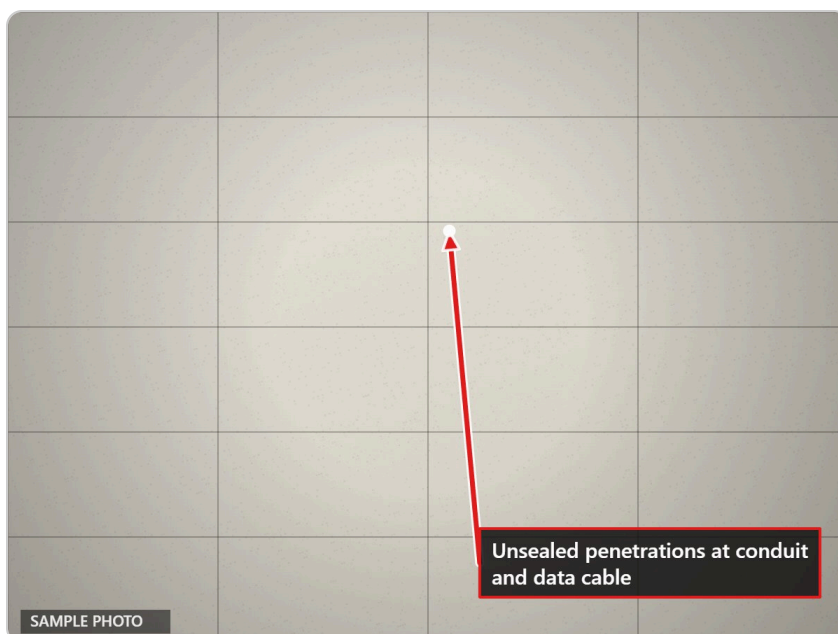
**Notes:** Unsealed penetrations were observed through the demising walls above the ceiling at seven locations where conduit, data cable and piping pass through. The demising walls appear intended as rated separations between tenant spaces, and every unsealed penetration defeats that rating.

**Recommendation:** Have the penetrations firestopped with a tested assembly by a qualified contractor. Obtain the approved construction drawings during diligence to confirm the required rating.

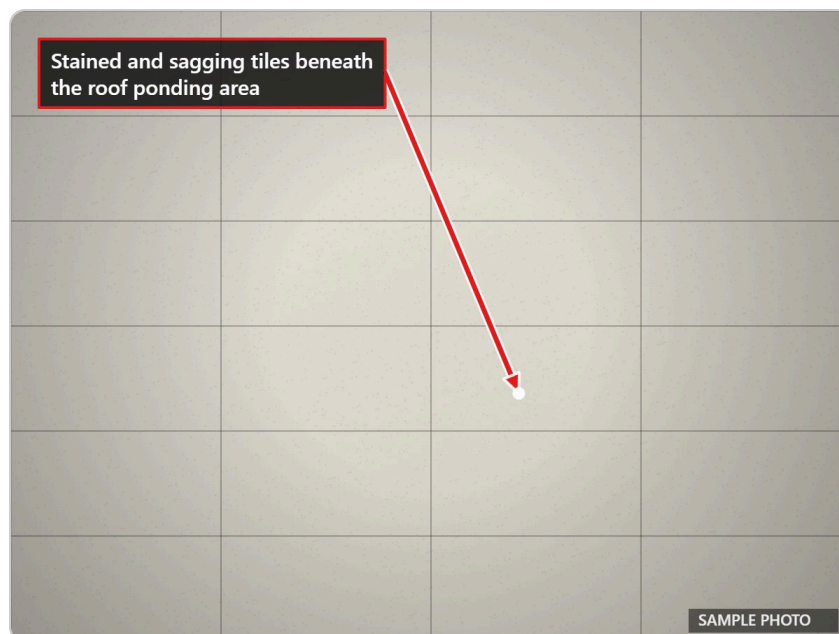
**Notes:** Approximately thirty stained or sagging ceiling tiles across the two suites, concentrated beneath the roof ponding areas and below two RTU curbs.

**Recommendation:** Replace the tiles after the roof drainage and RTU condensate issues are corrected, not before.

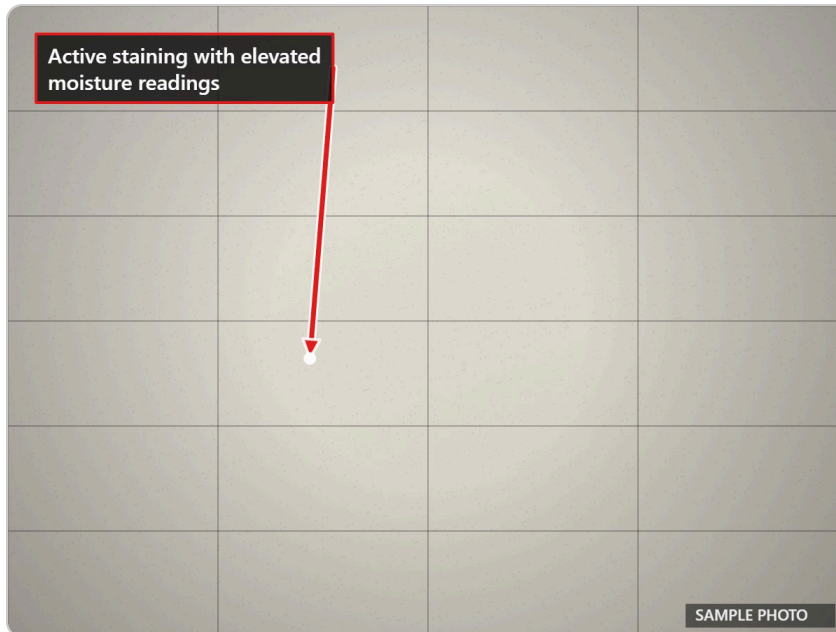
**Notes:** Active staining on the Suite C north wall below the parapet, with an elevated moisture meter reading relative to adjacent wall area. The location corresponds to the failed coping sealant recorded under Roof.

**Recommendation:** Correct the coping and control joint sealant, then dry and re-evaluate the wall. If the cavity has held water through multiple seasons, have the wall opened for inspection.
