# HUD REAC PRE-INSPECTION

## Cedar Ridge Apartments (Sample Property)

2150 Cedar Ridge Drive, Temecula, CA 92592

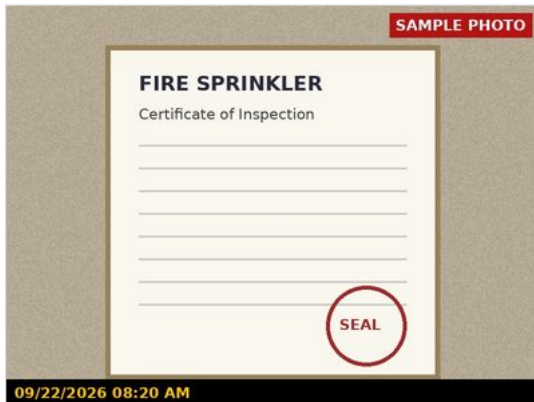
#### Sprinkler system

Expires in 18 days (2026-10-10) - renew before a REAC inspection.  
Annual inspection due - schedule before REAC.

**Present - expiring**

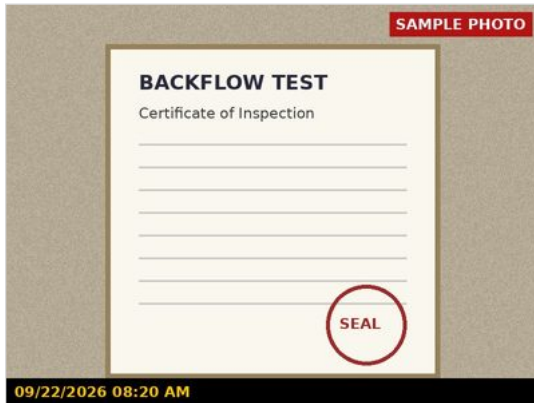
#### Other certificate

Expired 52 days ago (2026-08-01).  
Backflow preventer test.

**Present - EXPIRED**

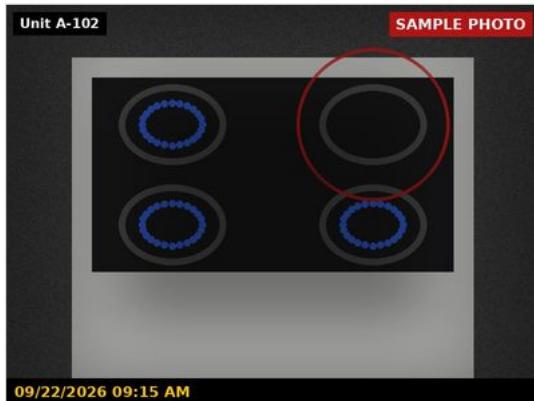
#### **1. COOKING APPLIANCE - A burner does not produce heat, but at least 1 other burner is present on the cooking range or cooktop and does produce heat.**

Left rear burner does not ignite; igniter clicks, no flame. Other three burners operate.

Left rear burner - no flame when tested

Repair or replace the burner so that it operates as intended.

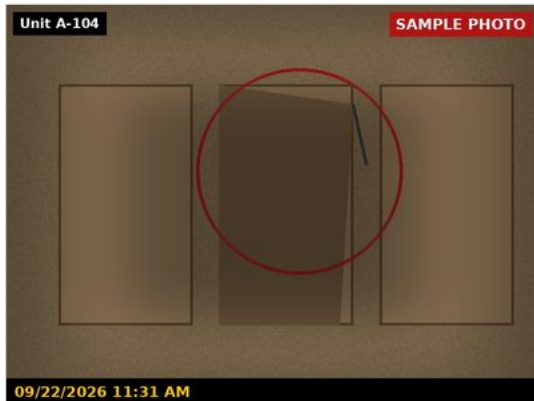
#### 4. CABINET AND STORAGE - Storage component is damaged, inoperable, or missing.

Cabinet door detached

Repair or replace the storage component so that it is fully operable.

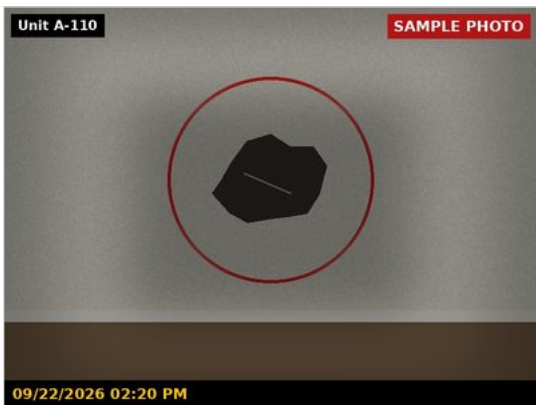
Hole behind entry door

Patch or replace the affected area so the surface is continuous and sound.

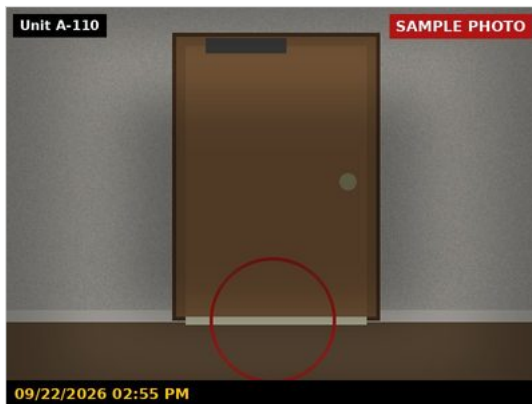
## 8. DOOR – ENTRY - Entry door seal, gasket, or stripping is damaged, inoperable, or missing.

Weatherstripping missing along the latch side of the entry door; daylight visible.

Weatherstripping missing

Repair or replace the entry door seal, gasket, or stripping so that it is fully operable.

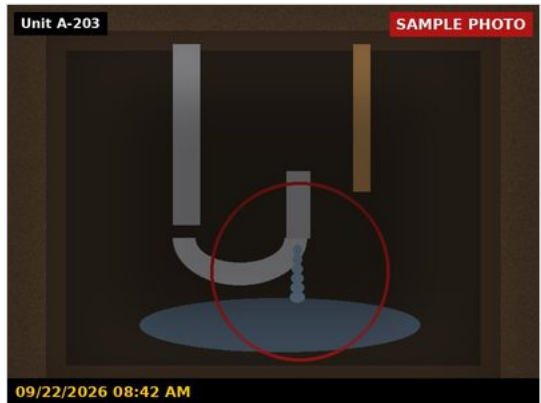
## 9. LEAK – WATER - Plumbing leak.

Active drip at the P-trap slip joint under the kitchen sink. Cabinet floor is water-stained and soft.

Active leak at P-trap

Cabinet floor damage

Have the failed pipe, fitting, or fixture connection repaired or replaced, then dry and make good the damaged materials.

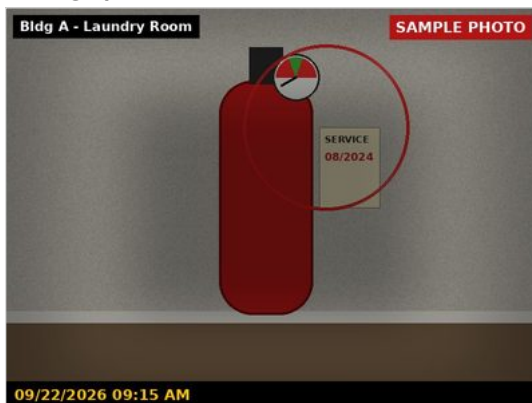
### 15. FIRE EXTINGUISHER - Fire extinguisher service tag is missing, illegible, or expired.

Expired service tag

Have the extinguisher serviced by a licensed fire equipment servicer and a current, legible service tag fitted. A nonchargeable or disposable extinguisher more than twelve years old by its manufacture date cannot be serviced and must be replaced.

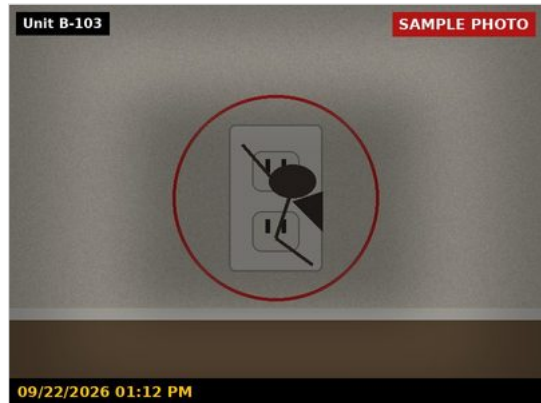
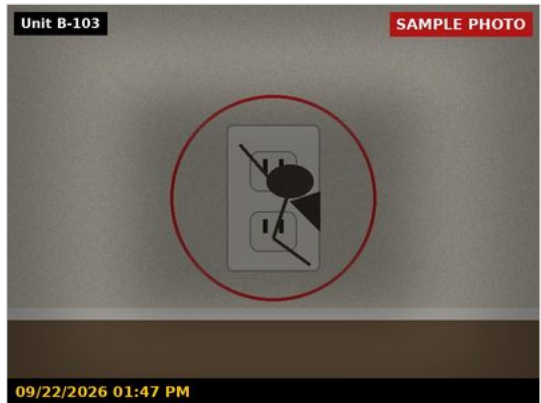
#### 21. ELECTRICAL – CONDUCTOR, OUTLET, AND SWITCH - Outlet or switch is damaged.

Cracked receptacle

Close-up

Have a licensed electrician de-energize the circuit and repair or replace the damaged outlet or switch before the circuit is restored.

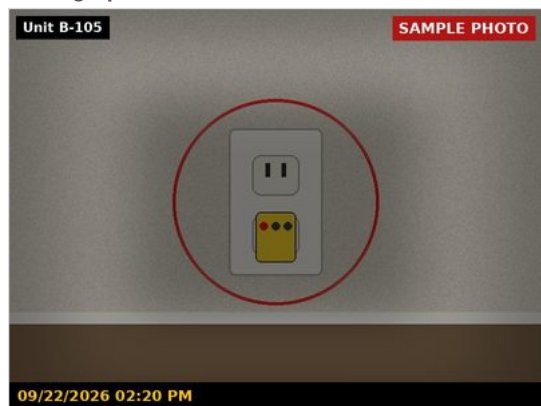
GFCI fails to trip

Repair or replace the GFCI outlet or GFCI breaker so that it is fully operable.

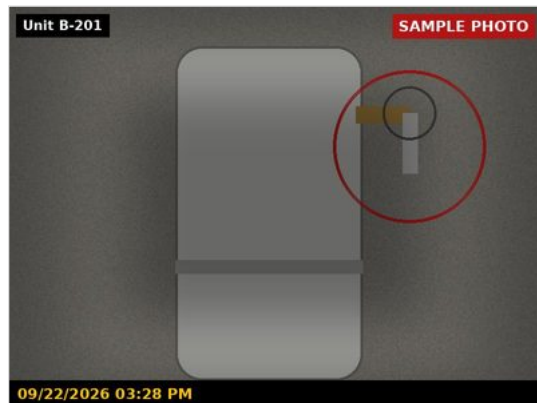
TPR discharge capped

Close-up of TPR valve

Have a licensed plumber replace the temperature pressure relief (TPR) valve. A TPR valve is not repaired, and it is never plugged, capped, or blocked - it is the water heater's only protection against rupture.

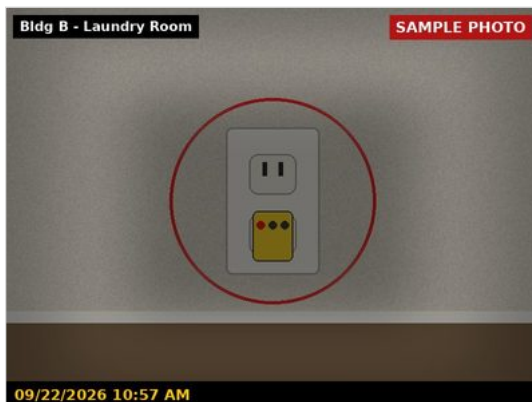
GFCI fails to trip

Repair or replace the GFCI outlet or GFCI breaker so that it is fully operable.

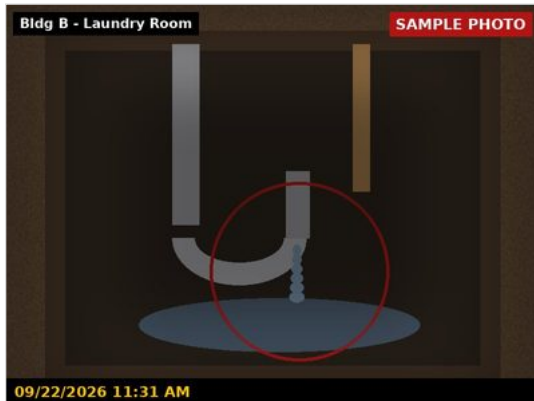
##### **27. LEAK – WATER - Plumbing leak.**

Leak at washer supply

Have the failed pipe, fitting, or fixture connection repaired or replaced, then dry and make good the damaged materials.

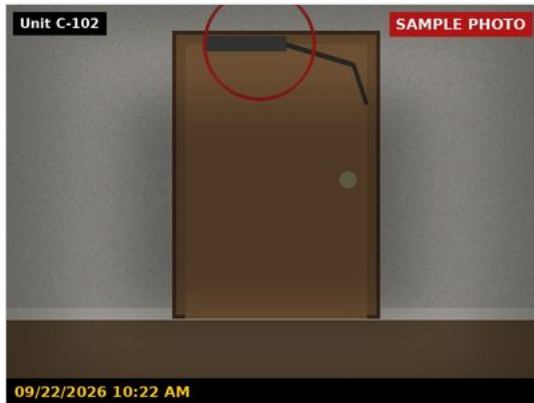
Closet door off track

Repair or replace the passage door component so that it is fully operable.

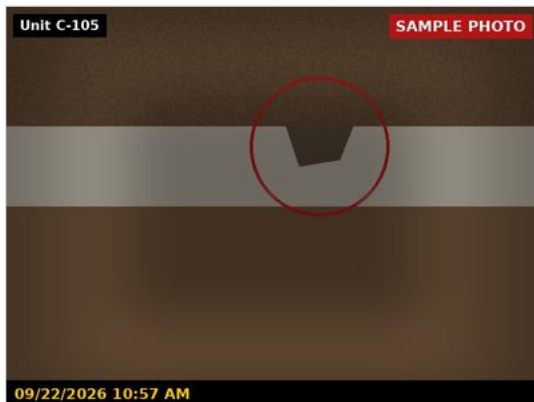
Countertop damaged at sink

Repair or replace the damaged food preparation area.

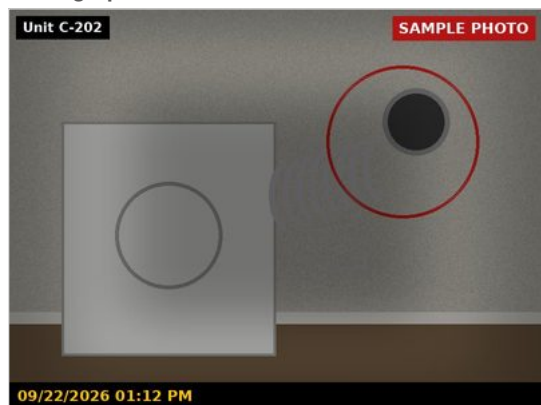
Transition duct detached

Reconnect the electric dryer to its exhaust with listed metal transition duct and confirm the run discharges outdoors.

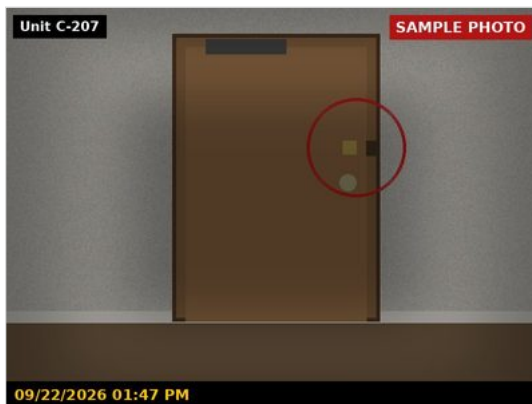
Deadbolt does not engage strike

Repair or replace the hardware so that the entry door can be secured.

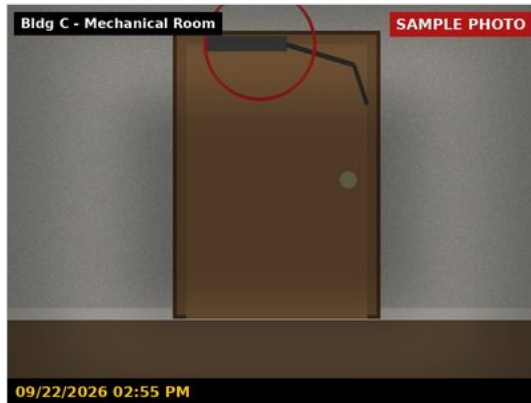
Door does not latch

Closer arm disconnected

Adjust or replace the hardware so that the fire labeled door closes and latches properly on its own.

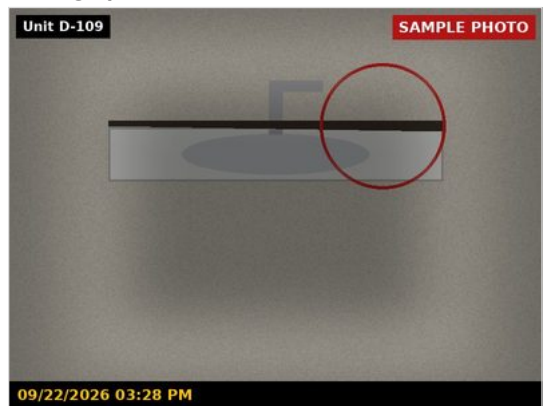
Sink pulling from wall

Re-secure the sink to the wall or cabinet, re-level it, and re-seal the joint so it is solid and watertight.

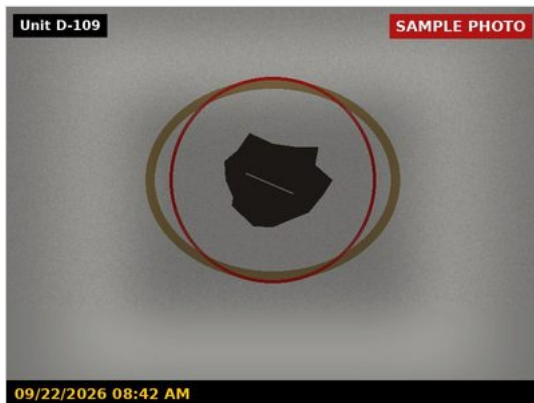
### 43. CEILING - Ceiling has an unstable surface.

Unstable ceiling surface over shower

Make the surface stable, repairing or replacing the affected material.

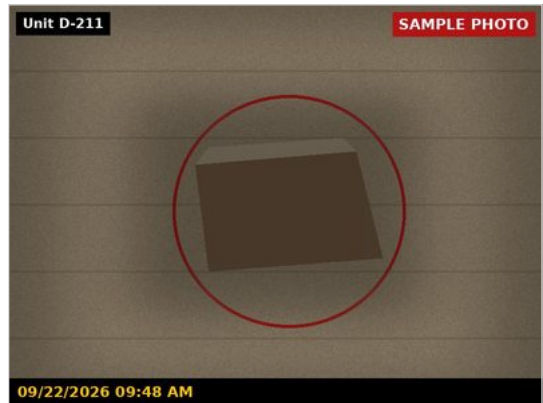
Floor substrate exposed

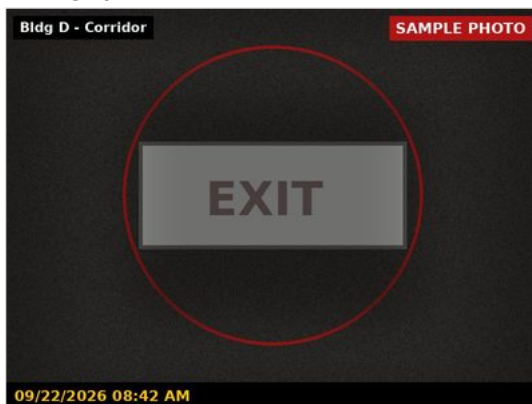
Exit sign not illuminated

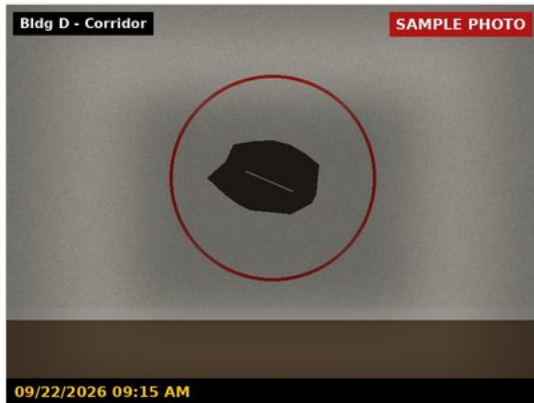
#### **47. WALL – INTERIOR - Interior wall has a hole that is greater than 2 inches in diameter or there is an accumulation of holes that are cumulatively greater than 6 inches by 6 inches.**

Hole in corridor wall

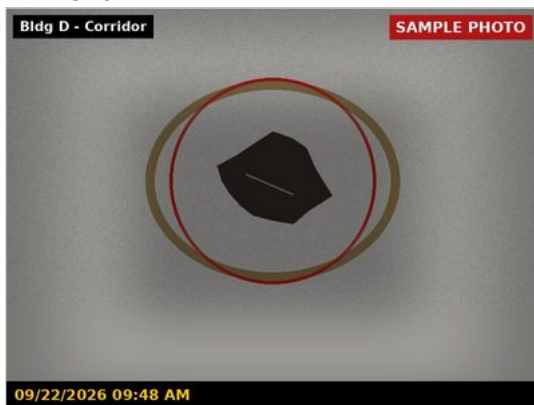
### 48. CEILING - Ceiling has a hole.

Hole in ceiling

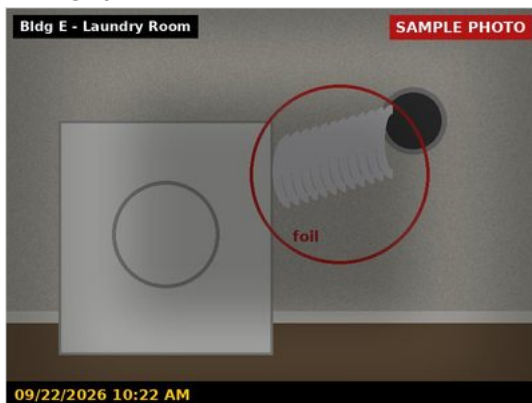
Foil transition duct

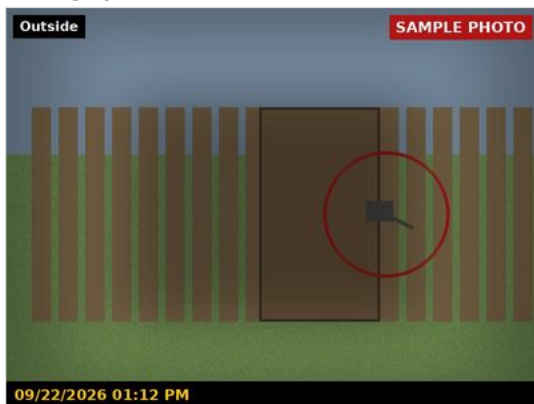
Gate will not latch

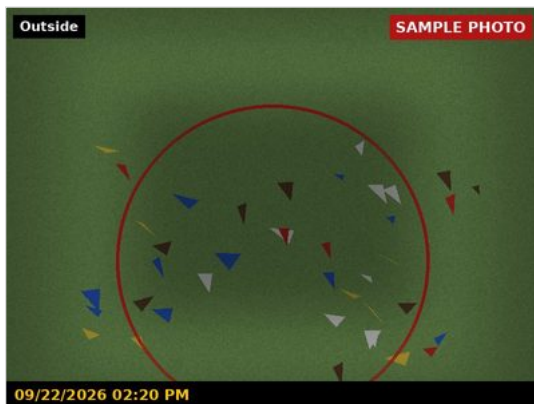
Litter behind Building D

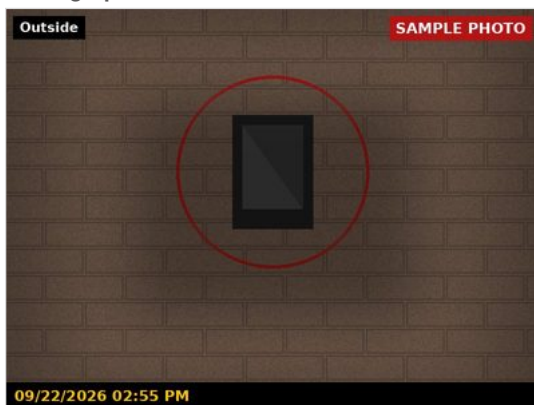
Fixture inoperable - Bldg C entry

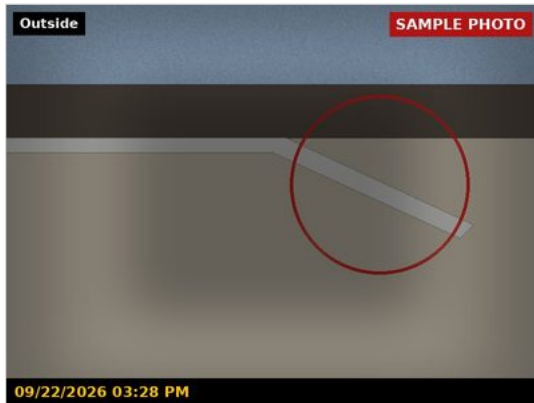
### 63. ROOF ASSEMBLY - Gutter component is damaged, missing, or unfixed.

Detached gutter - Bldg D

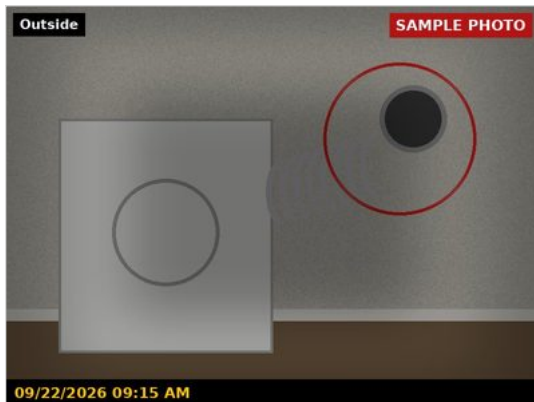
### **65. CLOTHES DRYER EXHAUST VENTILATION - Exterior dryer vent cover, cap, or a component thereof is missing.**

Vent cover missing - Bldg B

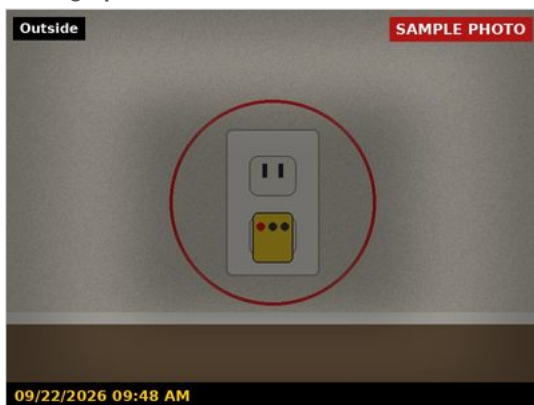
**66. ELECTRICAL – GROUND-FAULT CIRCUIT INTERRUPTER (GFCI) OR ARC-FAULT CIRCUIT INTERRUPTER (AFCI) – OUTLET OR BREAKER - GFCI outlet or GFCI breaker is not visibly damaged and the test or reset button is inoperable.**

Exterior GFCI fails to trip
