# Uniform Mitigation Verification Inspection Form

| Address: 4417 Palm Hollow Drive | | Home Phone: (941) 555-0163 |

# Photograph Addendum

OIR-B1-1802 (Rev. 04/26) - 4417 Palm Hollow Drive, Port Charlotte, FL 33948 - 09/25/2026

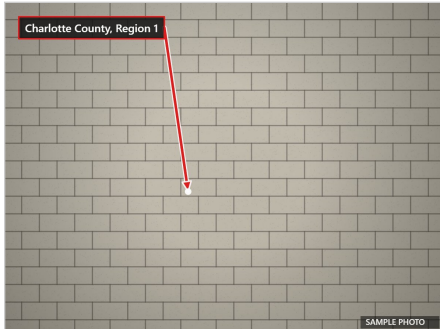
## FORM QUESTION 2

Marked: Region 1 (140 mph or greater)

Front elevation, address visible - Charlotte County, Region 1

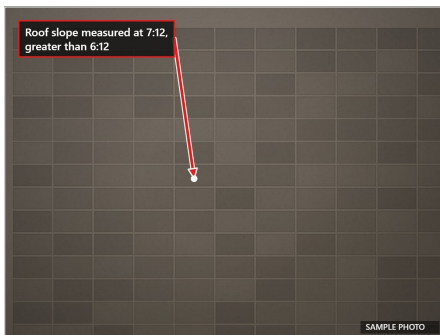
## FORM QUESTION 3

Marked: 6:12 or greater

Roof slope measured at 7:12, greater than 6:12

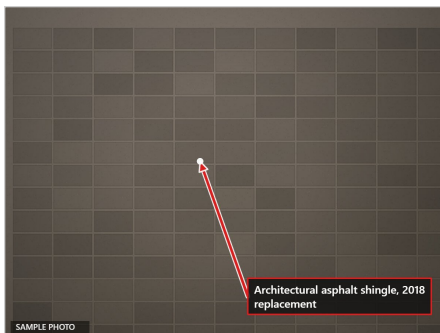
## FORM QUESTION 4

Marked: Asphalt / Fiberglass Shingle

Architectural asphalt shingle, 2018 replacement

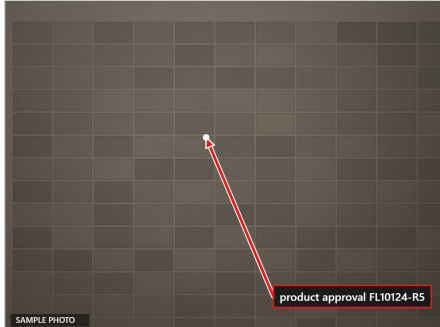
## FORM QUESTION 4.2

Marked: All meet FBC / MDC approval, or permit on or after 3/1/02, or original and built 2004+

Shingle wrapper - product approval FL10124-R5

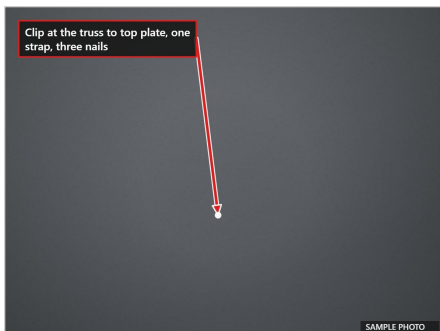
## FORM QUESTION 6

Marked: B - Clips

Clip at the truss to top plate, one strap, three nails

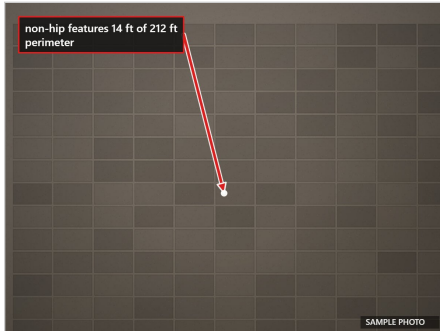
## FORM QUESTION 7

Marked: Hip Roof - non-hip features 10% or less of total perimeter

Hip roof - non-hip features 14 ft of 212 ft perimeter

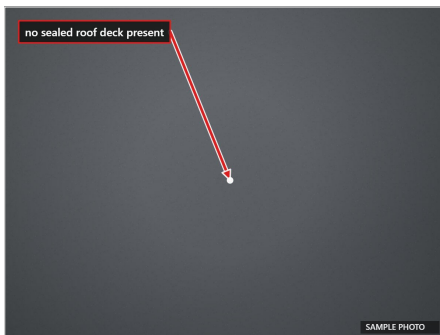
## FORM QUESTION 8

Marked: B - No Sealed Roof Deck

Underside of the deck - no sealed roof deck present

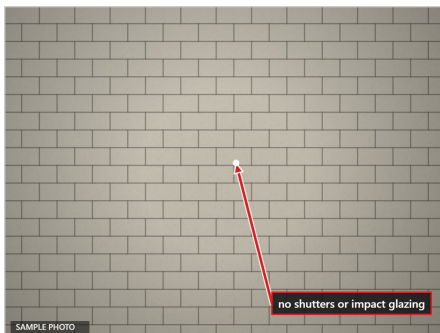
## FORM QUESTION 9

Marked: N - Unverified shutter systems, no documentation

Front glazed opening - no shutters or impact glazing
